## General Information

Date & Time: 13, Oct, 2025 10:40

<b>Make</b>	Nissan	<b>Model</b>	Navara
<b>YOM</b>	2019	<b>Odo Meter Reading</b>	50,282
<b>Registration No.</b>	NED7371	<b>Chassis No.</b>	MNTCC23Z0056647
<b>CC</b>	2.5	<b>Transmission</b>	A/T
<b>Fuel Type</b>	Diesel	<b>Type of Body</b>	Pickup
<b>Colour</b>	Brown

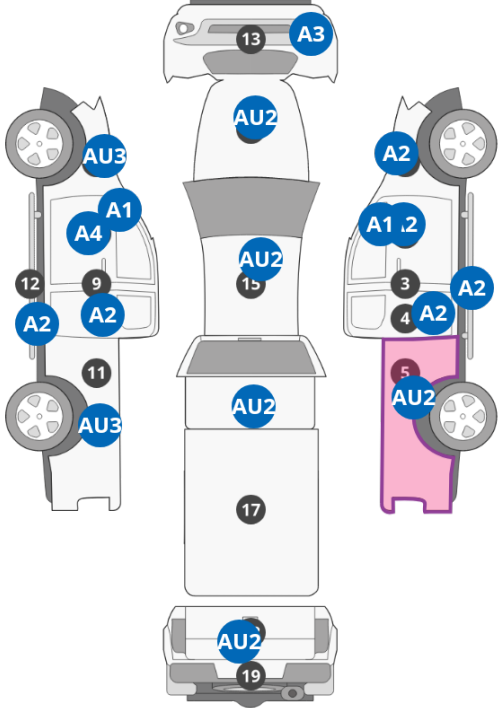
<p><b>A</b> : Scratch <b>AU</b> : Scratch &amp; Dent <b>B</b> : Modified <b>C</b> : Corrosion <b>G</b> : Stone chip <b>P</b> : Faded <b>S</b> : Rust <b>SC</b> : Rust &amp; Corrosion <b>U</b> : Dent <b>X</b> : Defective <b>Y</b> : Crack, Gap</p>
<b>Remarks</b> Ceiling - Grime - Small	<b>Remarks</b> (R) Side Gate - Repair mark - Yes / (L) Rear Door, Molding - Scratch - Small / (L) Front Door, Molding - Scratch - Large / (L) Front Fender, Molding - Scratch & Dent - Medium / Front Bumper, Grille, Lamps - Scratch - Medium / Bonnet, Headlight - Scratch & Dent - Small / (R) Front Fender, Molding - Scratch - Small / (R) Front Door, Molding - Scratch - Small / (R) Rear Door, Molding - Scratch - Small / (R) Side Gate - Scratch & Dent - Small / Rear Gate - Scratch & Dent - Small / (L) Side Gate - Scratch & Dent - Medium / (L) Step, In-panel, Side Spoiler - Scratch - Small / (R) Step, In-panel, Side Spoiler - Scratch - Small / Cab Back Panel - Scratch & Dent - Small / Roof - Scratch & Dent - Small / (L) Mirror - Scratch - Minimal / (R) Mirror - Scratch - Minimal
