## General Information

<b>Make</b>	Hyundai	<b>Model</b>	Eon
<b>YOM</b>	2016	<b>Odo Meter Reading</b>	59,541
<b>Registration No.</b>	NCI7483	<b>Chassis No.</b>	MALA251AAHM486608
<b>CC</b>	0.8	<b>Transmission</b>	M/T
<b>Fuel Type</b>	Gas	<b>Type of Body</b>	Car Sub Compact
<b>Colour</b>	Blue

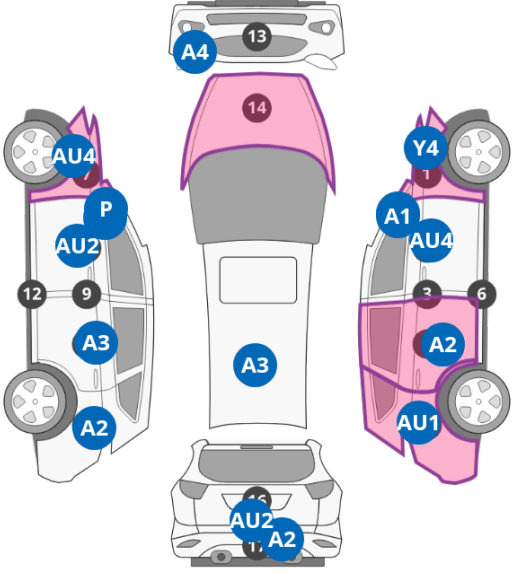
<p><b>A</b> : Scratch <b>AU</b> : Scratch &amp; Dent <b>B</b> : Modified <b>C</b> : Corrosion <b>G</b> : Stone chip <b>P</b> : Faded <b>S</b> : Rust <b>SC</b> : Rust &amp; Corrosion <b>U</b> : Dent <b>X</b> : Defective <b>Y</b> : Crack, Gap</p>
<p><b>Remarks</b> (L) Front Floor Mat - Missing - Yes / Overall Interior - Worn as per age - Yes / Ceiling - Grime - Medium</p>	<p><b>Remarks</b> (R) Front Door - Repair Traces - Yes / Bonnet - Repair Traces - Yes / (L) Front Fender - Repair Traces - Yes / (R) Rear Fender - Repair Traces - Yes / (R) Rear Door - Repair Traces - Yes / Front Bumper, Grille, Lamps - Scratch - Large / (R) Rear Door, Molding - Repair mark - Yes / (R) Rear Fender, Molding - Repair mark - Yes / (R) Front Fender, Molding - Repair mark - Yes / Bonnet, Headlight - Repair mark - Yes / (L) Front Fender, Molding - Repair mark - Yes / (L) Front Fender, Molding - Scratch &amp; Dent - Large / Overall Exterior - Faded(Color, Gloss) - Yes / (L) Mirror - Scratch - Minimal / (L) Mirror - Faded(Color, Gloss) - Yes / (R) Front Fender, Molding - Crack, Gap - Large / (R) Front Door, Molding - Scratch &amp; Dent - Large / (R) Rear Door, Molding - Scratch - Small / (R) Rear Fender, Molding - Scratch &amp; Dent - Minimal / (R) Mirror - Faded(Color, Gloss) - Yes / (R) Mirror - Scratch - Minimal / Rear Bumper, Lamps, Panels - Scratch - Small / Trunk Hood, Rear Gate - Scratch &amp; Dent - Small / (L) Rear Fender, Molding - Scratch - Small / (L) Rear Door, Molding - Scratch - Medium / (L) Front Door, Molding - Scratch &amp; Dent - Small / Roof - Scratch - Medium</p>
