General Information

Make	BMW	Model	520D
YOM	2015	Odo Meter Reading	96,824
Registration No.	ABD6171	Chassis No.	WBA5E0XG059709
CC	2.0	Transmission	A/T
Fuel Type	Diesel	Type of Body	Sedan
Colour	Black

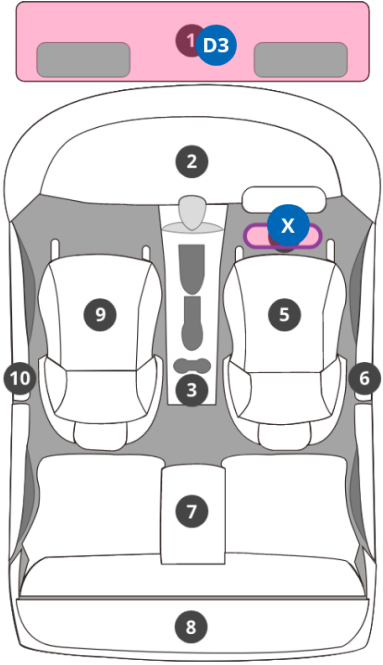
Interior Evaluation : B	Exterior Evaluation : E

<p>a : Cut, Fray d : Loose, Deformed k : Animal Hair s : Smell t : Cigarette Burns x : Defective y : Stain</p>

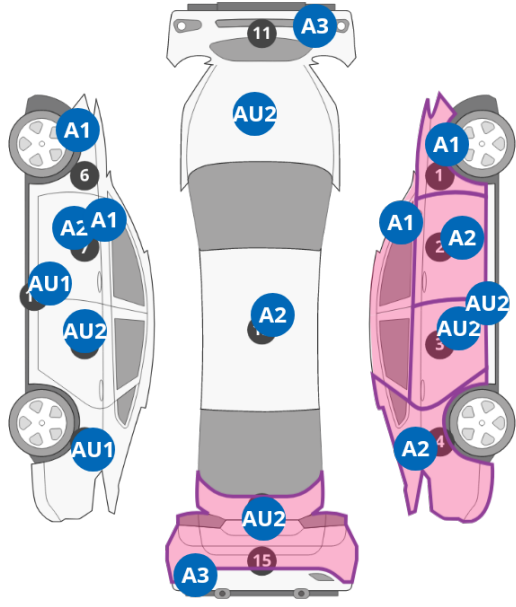
<p>A : Scratch AU : Scratch & Dent B : Modified C : Corrosion G : Stone chip P : Faded S : Rust SC : Rust & Corrosion U : Dent X : Defective Y : Crack, Gap</p>
Remarks (L) Front Floor Mat - Missing - Yes / Mat Other - Missing - Yes / (R) Front Floor Mat - Missing - Yes / Ceiling - Loose, Deformed - Medium	Remarks (R) Front Door - Repair Traces - Yes / (R) Front Fender - Repair Traces - Yes / Trunk Hood, Rear Gate - Repair Traces - Yes / (R) Rear Door - Repair Traces - Yes / (R) Front Fender, Molding - Repair mark - Yes / (R) Front Door, Molding - Repair mark - Yes / (R) Rear Door, Molding - Repair mark - Yes / (R) Rear Fender, Molding - Repair mark - Yes / Trunk Hood, Rear Gate - Repair mark - Yes / Front Bumper, Grille, Lamps - Scratch - Medium / (R) Front Fender, Molding - Scratch - Minimal / (R) Front Door, Molding - Scratch - Small / (R) Rear Door, Molding - Scratch & Dent - Small / (R) Step, In-panel, Side Spoiler - Scratch & Dent - Small / (R) Rear Fender, Molding - Scratch - Small / (R) Mirror - Scratch - Minimal / Rear Bumper, Lamps, Panels - Scratch - Medium / Trunk Hood, Rear Gate - Scratch & Dent - Small / (L) Rear Fender, Molding - Scratch & Dent - Minimal / (L) Rear Door, Molding - Scratch & Dent - Small / (L) Front Door, Molding - Scratch - Small / (L) Step, In-panel, Side Spoiler - Scratch & Dent - Minimal / (L) Front Fender, Molding - Scratch - Minimal / (L) Mirror - Scratch - Minimal / Roof - Scratch - Small / Bonnet, Headlight - Scratch & Dent - Small
