General Information

| Make | Toyota | Model | Vios |
| Registration No. | NKD7145 | Chassis No. | PA1B18F3XR4258896 |

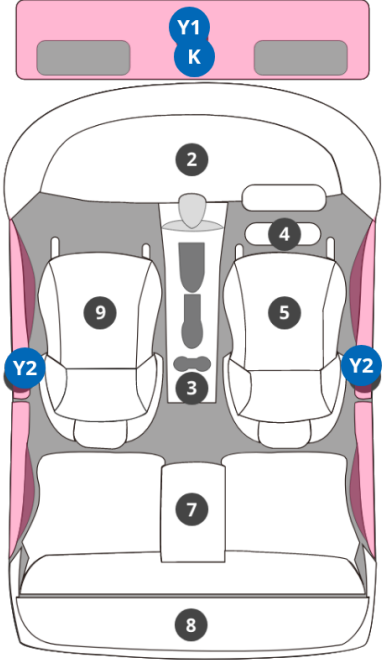
| Interior Evaluation : B | Exterior Evaluation : E |
| <p>Remarks Ceiling - Grime - Minimal / Overall Interior - Animal Hair - Yes / (R) Front Trim - Grime - Small / (L) Front Trim - Grime - Small</p> | <p>Remarks (L) Rear Fender, Molding - Scratch - Medium / (L) Rear Door, Molding - Scratch - Medium / (L) Mirror - Scratch - Small / (L) Front Fender, Molding - Scratch - Medium / (L) Step, In-panel, Side Spoiler - Scratch - Small / (L) Front Door, Molding - Scratch - Minimal / (R) Front Fender, Molding - Scratch - Small / Front Bumper, Grille, Lamps - Scratch & Dent - Medium / (R) Mirror - Scratch - Small / (R) Front Door, Molding - Scratch & Dent - Medium / (R) Rear Door, Molding - Scratch & Dent - Medium / (R) Rear Fender, Molding - Scratch - Small / Trunk Hood, Rear Gate - Scratch - Small / Rear Bumper, Lamps, Panels - Scratch - Medium / Roof - Scratch - Small</p> |
