## General Information

<b>Make</b>	Toyota	<b>Model</b>	Vios
<b>YOM</b>	2025	<b>Odo Meter Reading</b>	20,795
<b>Registration No.</b>	CCG4384	<b>Chassis No.</b>	PA1B18F31R4269723
<b>CC</b>	1.3	<b>Transmission</b>	CVT
<b>Fuel Type</b>	Gas	<b>Type of Body</b>	Sedan
<b>Colour</b>	Blackish Red Mica

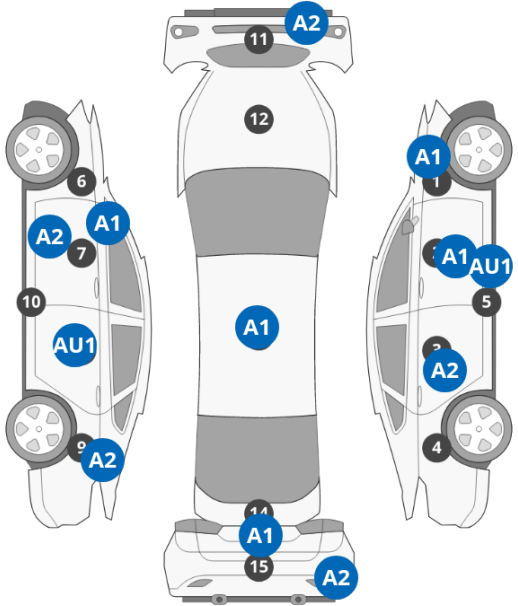
<p><b>A</b> : Scratch <b>AU</b> : Scratch &amp; Dent <b>B</b> : Modified <b>C</b> : Corrosion <b>G</b> : Stone chip <b>P</b> : Faded <b>S</b> : Rust <b>SC</b> : Rust &amp; Corrosion <b>U</b> : Dent <b>X</b> : Defective <b>Y</b> : Crack, Gap</p>
<p><b>Remarks</b> (L) Front Floor Mat - Worked - Small / Ceiling - Grime - Small</p>	<p><b>Remarks</b> Trunk Hood, Rear Gate - Scratch - Minimal / (R) Rear Door, Molding - Scratch - Small / (R) Front Door, Molding - Scratch - Minimal / (L) Rear Door, Molding - Scratch &amp; Dent - Minimal / (L) Front Door, Molding - Scratch - Small / (L) Mirror - Scratch - Minimal / Front Bumper, Grille, Lamps - Scratch - Small / (R) Front Fender, Molding - Scratch - Minimal / (R) Step, In-panel, Side Spoiler - Scratch &amp; Dent - Minimal / Roof - Scratch - Minimal / Rear Bumper, Lamps, Panels - Scratch - Small / (L) Rear Fender, Molding - Scratch - Small</p>
