## General Information

Date & Time: 13, Oct, 2025 18:20

<b>Make</b>	Toyota	<b>Model</b>	Vios
<b>YOM</b>	2021	<b>Odo Meter Reading</b>	54,510
<b>Registration No.</b>	NEP9477	<b>Chassis No.</b>	PA1B18F3256421420
<b>CC</b>	1.3	<b>Transmission</b>	CVT
<b>Fuel Type</b>	Gas	<b>Type of Body</b>	Sedan
<b>Colour</b>	Blue

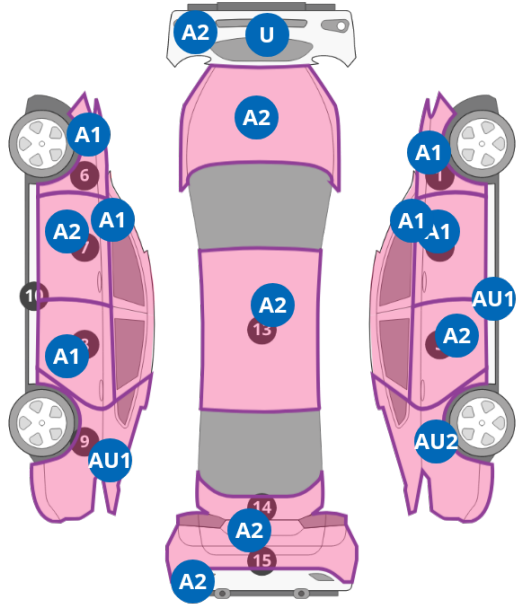
<p><b>A</b> : Scratch <b>AU</b> : Scratch &amp; Dent <b>B</b> : Modified <b>C</b> : Corrosion <b>G</b> : Stone chip <b>P</b> : Faded <b>S</b> : Rust <b>SC</b> : Rust &amp; Corrosion <b>U</b> : Dent <b>X</b> : Defective <b>Y</b> : Crack, Gap</p>
<p><b>Remarks</b> Overall Interior - Smell - Yes / Ceiling - Grime - Small / (L) Front Floor Mat - Worked - Small / (L) Front Trim - Worked - Small / (R) Front Trim - Worked - Small</p>	<p><b>Remarks</b> (R) Front Door - Repair Traces - Yes / (R) Front Fender - Repair Traces - Yes / Bonnet - Repair Traces - Yes / (L) Front Fender - Repair Traces - Yes / (L) Front Door - Repair Traces - Yes / (L) Rear Door - Repair Traces - Yes / (L) Rear Fender - Repair Traces - Yes / Trunk Hood, Rear Gate - Repair Traces - Yes / (R) Rear Fender - Repair Traces - Yes / (R) Rear Door - Repair Traces - Yes / Roof - Repair Traces - Yes / Trunk Hood, Rear Gate - Repair mark - Yes / (L) Rear Fender, Molding - Repair mark - Yes / (L) Rear Door, Molding - Repair mark - Yes / (L) Front Door, Molding - Repair mark - Yes / (L) Front Fender, Molding - Repair mark - Yes / Bonnet, Headlight - Repair mark - Yes / (R) Front Fender, Molding - Repair mark - Yes / (R) Front Door, Molding - Repair mark - Yes / (R) Rear Door, Molding - Repair mark - Yes / (R) Rear Fender, Molding - Repair mark - Yes / Roof - Repair mark - Yes / Member (Bolted) - Dent - Yes / Front Bumper, Grille, Lamps - Scratch - Small / (L) Rear Fender, Molding - Scratch &amp; Dent - Minimal / (L) Rear Door, Molding - Scratch - Minimal / (L) Front Door, Molding - Scratch - Small / (L) Front Fender, Molding - Scratch - Minimal / (L) Mirror - Scratch - Minimal / Trunk Hood, Rear Gate - Scratch - Small / Rear Bumper, Lamps, Panels - Scratch - Small / (R) Rear Fender, Molding - Scratch &amp; Dent - Small / (R) Rear Door, Molding - Scratch - Small / (R) Front Door, Molding - Scratch - Minimal / (R) Front Fender, Molding - Scratch - Minimal / (R) Mirror - Scratch - Minimal / (R) Step, In-panel, Side Spoiler - Scratch &amp; Dent - Minimal / Bonnet, Headlight - Scratch - Small / Roof - Scratch - Small</p>
