## General Information

Date & Time: 15, Oct, 2025 16:44

<b>Make</b>	Mitsubishi	<b>Model</b>	Mirage
<b>YOM</b>	2024	<b>Odo Meter Reading</b>	23,942
<b>Registration No.</b>	NHR4391	<b>Chassis No.</b>	PAEA13TJRPA014518
<b>CC</b>	1.2	<b>Transmission</b>	CVT
<b>Fuel Type</b>	Gas	<b>Type of Body</b>	Sedan
<b>Colour</b>	White

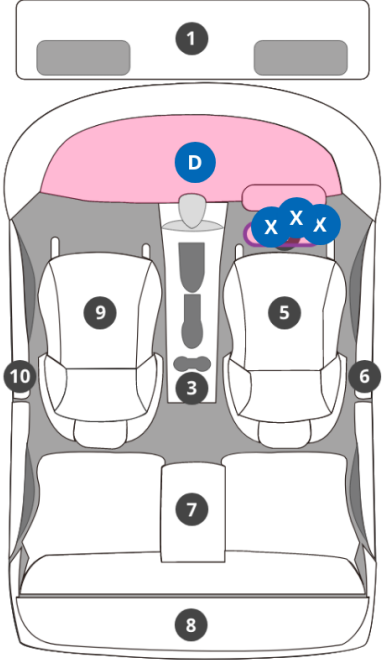
<b>Interior Evaluation :</b> <span style="float: right;"><b>B</b></span>	<b>Exterior Evaluation :</b> <span style="float: right;"><b>E</b></span>

<p><b>a</b> : Cut, Fray <b>d</b> : Loose, Deformed <b>k</b> : Animal Hair <b>s</b> : Smell <b>t</b> : Cigarette Burns <b>x</b> : Defective <b>y</b> : Stain</p>

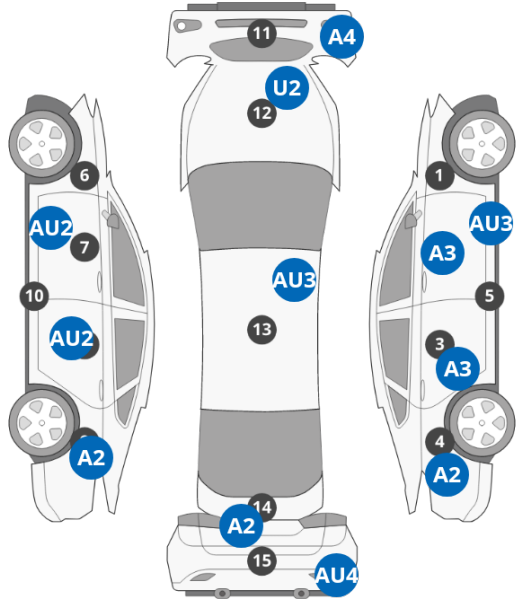
<p><b>A</b> : Scratch <b>AU</b> : Scratch &amp; Dent <b>B</b> : Modified <b>C</b> : Corrosion <b>G</b> : Stone chip <b>P</b> : Faded <b>S</b> : Rust <b>SC</b> : Rust &amp; Corrosion <b>U</b> : Dent <b>X</b> : Defective <b>Y</b> : Crack, Gap</p>
<p><b>Remarks</b> (R) Front Floor Mat - Missing - Yes / (L) Front Floor Mat - Missing - Yes / Mat Other - Missing - Yes / Dashboard - Traces of Adhesive Tape - Yes</p>	<p><b>Remarks</b> (R) Front Door - Repair Traces - Yes / (R) Step - Repair Traces - Yes / (R) Front Fender - Repair Traces - Yes / (L) Front Fender - Repair Traces - Yes / (L) Front Door - Repair Traces - Yes / (L) Step - Repair Traces - Yes / (L) Rear Door - Repair Traces - Yes / (L) Rear Fender - Repair Traces - Yes / Trunk Hood, Rear Gate - Repair Traces - Yes / (R) Rear Fender - Repair Traces - Yes / (R) Rear Door - Repair Traces - Yes / Roof - Repair Traces - Yes / Roof - Scratch &amp; Dent - Medium / (R) Step, In-panel, Side Spoiler - Scratch &amp; Dent - Medium / (R) Front Door, Molding - Scratch - Medium / (R) Rear Door, Molding - Scratch - Medium / (R) Rear Fender, Molding - Scratch - Small / Rear Bumper, Lamps, Panels - Scratch &amp; Dent - Large / Trunk Hood, Rear Gate - Scratch - Small / (L) Rear Door, Molding - Scratch &amp; Dent - Small / (L) Front Door, Molding - Scratch &amp; Dent - Small / (L) Rear Fender, Molding - Scratch - Small / Front Bumper, Grille, Lamps - Scratch - Large / Bonnet, Headlight - Dent - Small</p>
