General Information

| Make | Toyota | Model | Fortuner |
| Registration No. | NHH6811 | Chassis No. | MHFCB3GSXR0495339 |

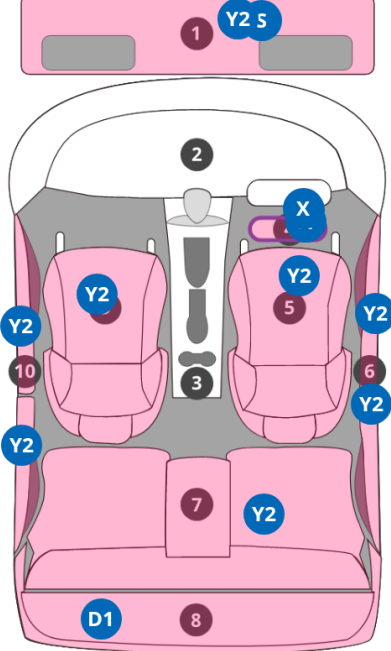
| Interior Evaluation : B | Exterior Evaluation : D |

| <p>Remarks (R) Front Floor Mat - Missing - Yes / (L) Front Floor Mat - Missing - Yes / Mat Other - Missing - Yes / Overall Interior - Smell - Yes / Ceiling - Grime - Small / (R) Front Seat - Grime - Small / (L) Front Seat - Grime - Small / (R) Front Trim - Grime - Small / Rear Seat - Grime - Small / (L) Front Trim - Grime - Small / (R) Rear Trim - Grime - Small / (L) Rear Trim - Grime - Small / Trunk Room - Worked - Minimal</p> | <p>Remarks Rear Bumper, Lamps, Panels - Scratch & Dent - Medium / Trunk Hood, Rear Gate - Scratch - Small / Front Bumper, Grille, Lamps - Scratch - Large / Bonnet, Headlight - Scratch & Dent - Medium / (R) Front Fender, Molding - Scratch - Small / (R) Front Door, Molding - Scratch - Small / (R) Rear Door, Molding - Scratch & Dent - Small / (R) Step, In-panel, Side Spoiler - Scratch - Small / (L) Rear Fender, Molding - Scratch - Small / (L) Rear Door, Molding - Scratch - Small / (L) Front Door, Molding - Scratch - Minimal / (L) Front Fender, Molding - Scratch - Minimal / (L) Mirror - Scratch - Minimal / (L) Step, In-panel, Side Spoiler - Scratch - Small / Roof - Scratch - Small</p> |

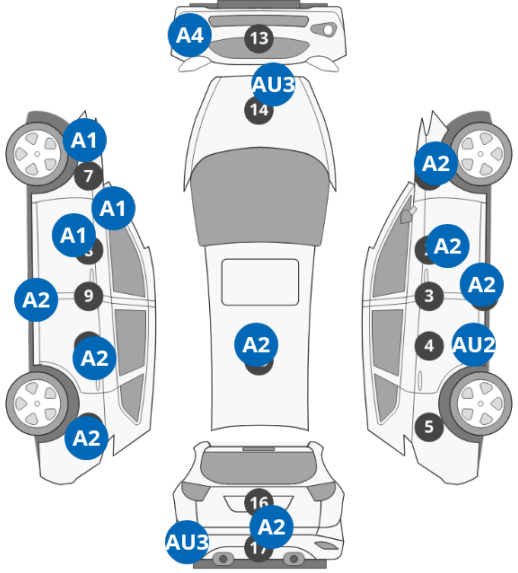
| <p>No LTO plate, Jack and Tools and Spare tire, with warranty booklet, scratch headlight and tail light, Worn Tires, horn issue.no spare key.</p> |
