## General Information

<b>Make</b>	Toyota	<b>Model</b>	Land Cruiser
<b>YOM</b>	2018	<b>Mileage</b>	66,868
<b>Registration No.</b>	NBM5048	<b>Chassis No.</b>	JTMHV01J6H4229797
<b>CC</b>	4.5	<b>Transmission</b>	A/T
<b>Fuel Type</b>	Diesel	<b>Type of Body</b>	SUV
<b>Colour</b>	Black

## Body / Panel Condition

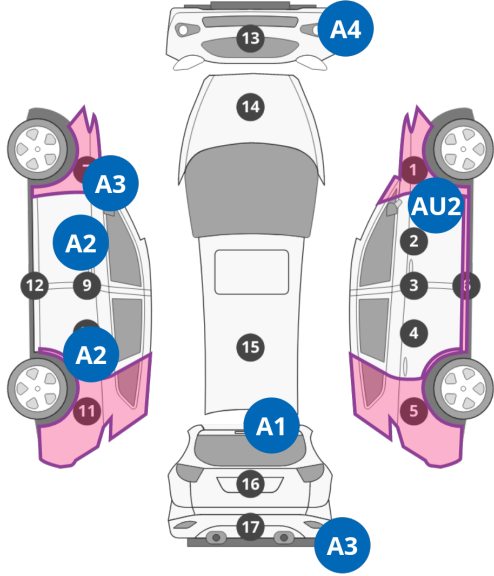
<p><b>A</b> : Scratch <b>AU</b> : Scratch &amp; Dent <b>B</b> : Modified <b>C</b> : Corrosion <b>G</b> : Stone chip <b>P</b> : Faded <b>S</b> : Rust <b>SC</b> : Rust &amp; Corrosion <b>U</b> : Dent <b>X</b> : Defective <b>Y</b> : Crack, Gap</p>
<p><b>Remarks</b> (R) Front Floor Mat - Missing - Yes / Mat Other - Missing - Yes</p>	<p><b>Remarks</b> (L) Front Fender, Molding - Scratch - Medium / (L) Front Door, Molding - Scratch - Small / (L) Rear Door, Molding - Scratch - Small / (L) Front Wheel, Cover - Cap Missing - Yes / (L) Rear Wheel, Cover - Cap Missing - Yes / (R) Rear Wheel, Cover - Cap Missing - Yes / (R) Front Wheel, Cover - Cap Missing - Yes / Rear Bumper, Lamps, Panels - Scratch - Medium / Front Bumper, Grille, Lamps - Scratch - Large / (R) Front Fender, Molding - Scratch &amp; Dent - Small / (R) Step, In-panel, Side Spoiler - Partially Missing - Yes / Roof Spoiler, Molding - Scratch - Minimal</p>
