## General Information

<b>Make</b>	Suzuki	<b>Model</b>	Dzire
<b>YOM</b>	2025	<b>Odo Meter Reading</b>	8,101
<b>Registration No.</b>	GBJ4099	<b>Chassis No.</b>	MBHZF63S8SG585971
<b>CC</b>	1.2	<b>Transmission</b>	A/T
<b>Fuel Type</b>	Gas	<b>Type of Body</b>	Sedan
<b>Colour</b>	Blue

## Body / Panel Condition

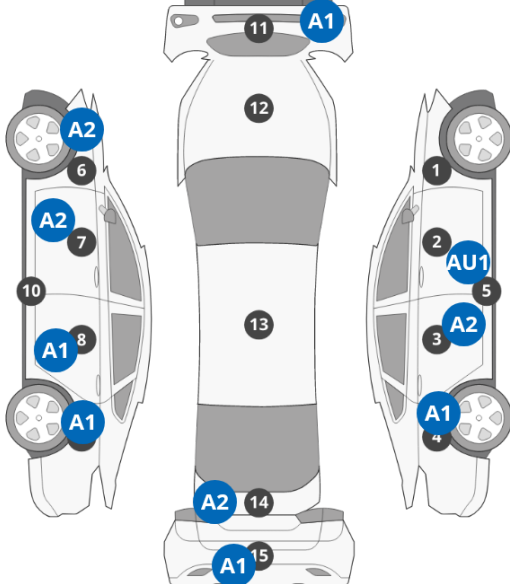
<p><b>A</b> : Scratch <b>AU</b> : Scratch &amp; Dent <b>B</b> : Modified <b>C</b> : Corrosion <b>G</b> : Stone chip <b>P</b> : Faded <b>S</b> : Rust <b>SC</b> : Rust &amp; Corrosion <b>U</b> : Dent <b>X</b> : Defective <b>Y</b> : Crack, Gap</p>
<p><b>Remarks</b> Ceiling - Grime - Minimal / (R) Front Trim - Grime - Small / Rear Seat - Grime - Medium / (L) Front Trim - Grime - Small</p>	<p><b>Remarks</b> (L) Front Fender, Molding - Scratch - Small / (L) Rear Fender, Molding - Scratch - Minimal / (L) Rear Door, Molding - Scratch - Minimal / (L) Front Door, Molding - Scratch - Small / Trunk Hood, Rear Gate - Scratch - Small / Rear Bumper, Lamps, Panels - Scratch - Minimal / (R) Rear Fender, Molding - Scratch - Minimal / (R) Rear Door, Molding - Scratch - Small / (R) Front Door, Molding - Scratch &amp; Dent - Minimal / Front Bumper, Grille, Lamps - Scratch - Minimal</p>
