## General Information

Date & Time: 28, Oct, 2025 18:03

Make	Mazda	Model	BT50
YOM	2015	Odo Meter Reading	103,767
Registration No.	NDW2335	Chassis No.	MM7UP4DFTFW404667
CC	3.2	Transmission	A/T
Fuel Type	Diesel	Type of Body	Double Cab. Pick-Up
Colour	Gray

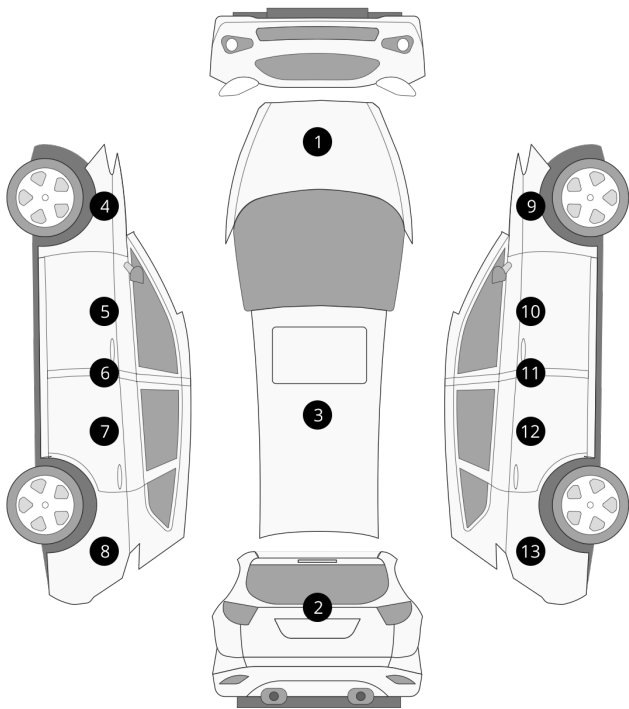
#	Area	Thickness(um)			
		Average	Value1	Value2	Value3/4
1	Bonnet	151.0	141	173	139
2	Boot Lid	167.0	181	130	190
3	Roof	138.0	135	129	138/150
4	Left Front Fender	138.0	131	142	141
5	Left Front Door	174.6	195	148	181
6	Center Panel Left				
7	Left Rear Door	156.0	174	144	150
8	Left Back Panel	143.3	134	140	156
9	Right Front Fender	178.6	273	138	125
10	Right Front Door	165.0	168	152	175
11	Center Panel Right				
12	Right Rear Door	157.3	160	148	164
13	Right Back Panel	152.3	143	172	142

<b>Interior Evaluation :</b>	C	<b>Exterior Evaluation :</b>	E
<p><b>a</b> : Cut, Fray <b>d</b> : Loose, Deformed <b>k</b> : Animal Hair <b>s</b> : Smell <b>t</b> : Cigarette Burns <b>x</b> : Defective <b>y</b> : Stain</p>		<p><b>A</b> : Scratch <b>AU</b> : Scratch &amp; Dent <b>B</b> : Modified <b>C</b> : Corrosion <b>G</b> : Stone chip <b>P</b> : Faded <b>S</b> : Rust <b>SC</b> : Rust &amp; Corrosion <b>U</b> : Dent <b>X</b> : Defective <b>Y</b> : Crack, Gap</p>	
<p><b>Remarks</b> (L) Front Seat - Cut, Crack - Large / Steering Wheel - Worn, Peel, Crack - Medium / Overall Interior - Worn as per age - Yes</p>		<p><b>Remarks</b> (R) Front Door - Repair Traces - Yes / (R) Step - Repair Traces - Yes / (R) Front Fender - Repair Traces - Yes / Bonnet - Repair Traces - Yes / (L) Front Fender - Repair Traces - Yes / (L) Front Door - Repair Traces - Yes / (L) Step - Repair Traces - Yes / (L) Rear Door - Repair Traces - Yes / (R) Rear Door - Repair Traces - Yes / (R) Front Door, Molding - Scratch - Large / (R) Rear Door, Molding - Scratch - Large / (R) Side Gate - Scratch - Medium / Rear Bumper, Lamps, Panels - Scratch &amp; Dent - Large / (L) Side Gate - Scratch - Large / (L) Rear Door, Molding - Scratch - Small / (L) Front Door, Molding - Scratch - Small / (L) Front Fender, Molding - Scratch - Small / Front Bumper, Grille, Lamps - Scratch - Large / (R) Front Fender, Molding - Scratch - Large / Roof - Dent - Small / Bonnet, Headlight - Dent - Small</p>
