General Information

Make	Toyota	Model	Wigo
YOM	2023	Odo Meter Reading	21,282
Registration No.	DBN3239	Chassis No.	MHKAA1BC1PJ004244
CC	1.0	Transmission	CVT
Fuel Type	Gas	Type of Body	Hatchback
Colour	Yellow

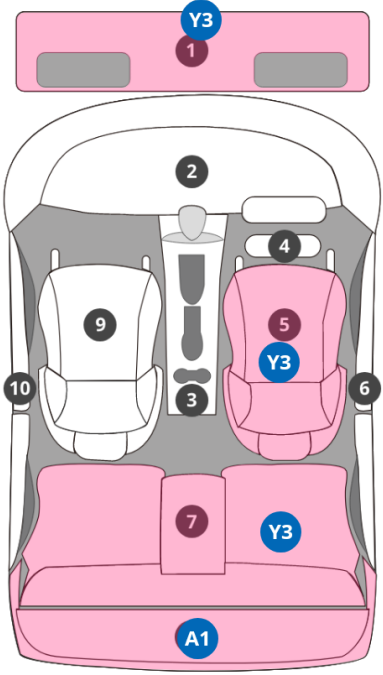
Interior Evaluation : B	Exterior Evaluation : C

<p>a : Cut, Fray d : Loose, Deformed k : Animal Hair s : Smell t : Cigarette Burns x : Defective y : Stain</p>

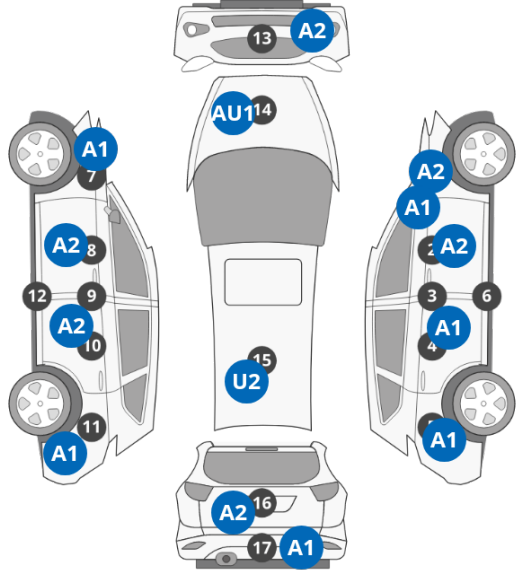
<p>A : Scratch AU : Scratch & Dent B : Modified C : Corrosion G : Stone chip P : Faded S : Rust SC : Rust & Corrosion U : Dent X : Defective Y : Crack, Gap</p>
<p>Remarks Rear Seat - Grime - Medium / (R) Front Seat - Grime - Medium / Trunk Room - Worn, Scratch, Cut, Crack - Minimal / Ceiling - Grime - Medium</p>	<p>Remarks (R) Front Door - Repair Traces - Yes / (R) Front Fender - Repair Traces - Yes / Bonnet - Repair Traces - Yes / (L) Front Fender - Repair Traces - Yes / (L) Front Door - Repair Traces - Yes / (L) Rear Door - Repair Traces - Yes / (L) Rear Fender - Repair Traces - Yes / Trunk Hood, Rear Gate - Repair Traces - Yes / (R) Rear Fender - Repair Traces - Yes / (R) Rear Door - Repair Traces - Yes / Roof - Repair Traces - Yes / Roof - Dent - Small / (L) Rear Fender, Molding - Scratch - Minimal / Trunk Hood, Rear Gate - Scratch - Small / (L) Rear Door, Molding - Scratch - Small / (L) Front Door, Molding - Scratch - Small / (R) Front Fender, Molding - Scratch - Small / Bonnet, Headlight - Scratch & Dent - Minimal / Front Bumper, Grille, Lamps - Scratch - Small / (R) Mirror - Scratch - Minimal / (R) Front Door, Molding - Scratch - Small / (R) Rear Fender, Molding - Scratch - Minimal / (R) Rear Door, Molding - Scratch - Minimal / (L) Front Fender, Molding - Scratch - Minimal / Rear Bumper, Lamps, Panels - Scratch - Minimal</p>
