## General Information

<b>Make</b>	Toyota	<b>Model</b>	Vios
<b>YOM</b>	2023	<b>Odo Meter Reading</b>	33,509
<b>Registration No.</b>	NFC9568	<b>Chassis No.</b>	PA1B18F34P4222358
<b>CC</b>	1.3	<b>Transmission</b>	CVT
<b>Fuel Type</b>	Gas	<b>Type of Body</b>	Sedan
<b>Colour</b>	Black

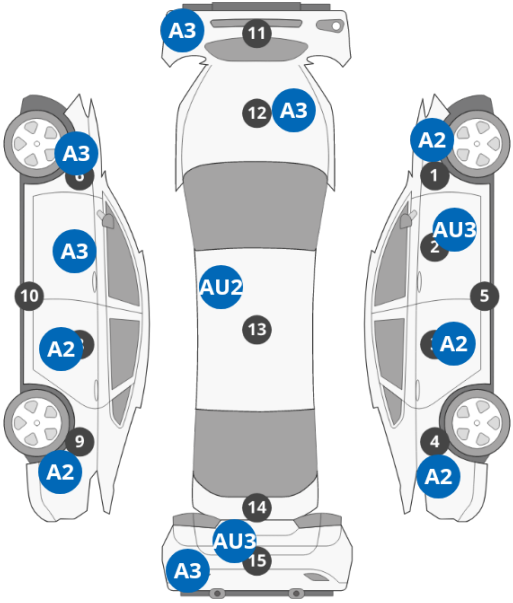
<p><b>A</b> : Scratch <b>AU</b> : Scratch &amp; Dent <b>B</b> : Modified <b>C</b> : Corrosion <b>G</b> : Stone chip <b>P</b> : Faded <b>S</b> : Rust <b>SC</b> : Rust &amp; Corrosion <b>U</b> : Dent <b>X</b> : Defective <b>Y</b> : Crack, Gap</p>
<p><b>Remarks</b> (R) Front Seat - Grime - Small / Rear Seat - Grime - Medium / (L) Front Floor Mat - Grime - Medium / Dashboard - Worn, Scratch, Cut, Crack - Small / Trunk Room - Worn, Scratch, Cut, Crack - Small / Ceiling - Grime - Medium</p>	<p><b>Remarks</b> (R) Front Fender - Repair Traces - Yes / Trunk Hood, Rear Gate - Scratch &amp; Dent - Medium / Rear Bumper, Lamps, Panels - Scratch - Medium / (L) Rear Fender, Molding - Scratch - Small / (L) Front Door, Molding - Scratch - Medium / (L) Rear Door, Molding - Scratch - Small / (L) Front Fender, Molding - Scratch - Medium / Front Bumper, Grille, Lamps - Scratch - Medium / Bonnet, Headlight - Scratch - Medium / (R) Front Fender, Molding - Scratch - Small / Roof - Scratch &amp; Dent - Small / (R) Rear Door, Molding - Scratch - Small / (R) Front Door, Molding - Scratch &amp; Dent - Medium / (R) Rear Fender, Molding - Scratch - Small</p>
