## General Information

<b>Make</b>	Toyota	<b>Model</b>	Avanza
<b>YOM</b>	2024	<b>Odo Meter Reading</b>	33,263
<b>Registration No.</b>	NFR2762	<b>Chassis No.</b>	MHFAA1BY2R0025297
<b>CC</b>	1.3	<b>Transmission</b>	CVT
<b>Fuel Type</b>	Gas	<b>Type of Body</b>	MPV
<b>Colour</b>	Green

## Body / Panel Condition

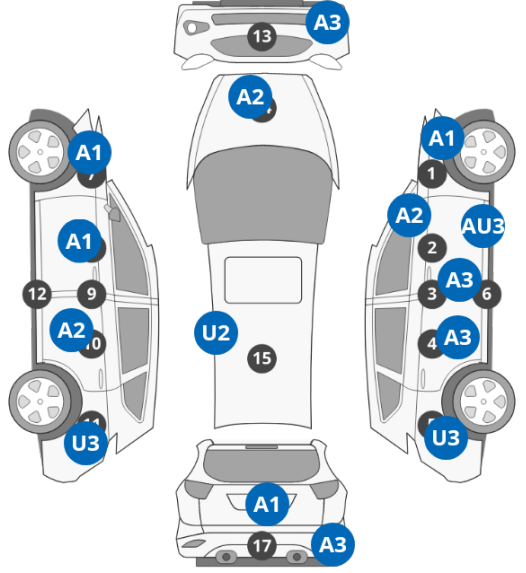
<p><b>A</b> : Scratch <b>AU</b> : Scratch &amp; Dent <b>B</b> : Modified <b>C</b> : Corrosion <b>G</b> : Stone chip <b>P</b> : Faded <b>S</b> : Rust <b>SC</b> : Rust &amp; Corrosion <b>U</b> : Dent <b>X</b> : Defective <b>Y</b> : Crack, Gap</p>
<p><b>Remarks</b>  Rear Seat - Grime - Medium / (R) Front Seat - Grime - Minimal / Trunk Room - Worn, Scratch, Cut, Crack - Small / (L) Front Floor Mat - Grime - Medium / Console, Switches, Vents - Worn, Scratch, Cut, Crack - Small / Ceiling - Grime - Small</p>	<p><b>Remarks</b>  Roof - Dent - Small / (L) Rear Door, Molding - Scratch - Small / (L) Rear Fender, Molding - Dent - Medium / Rear Bumper, Lamps, Panels - Scratch - Medium / (R) Rear Fender, Molding - Dent - Medium / (R) Rear Door, Molding - Scratch - Medium / (R) Front Door, Molding - Scratch - Medium / (R) Step, In-panel, Side Spoiler - Scratch &amp; Dent - Medium / (R) Mirror - Scratch - Small / (R) Front Fender, Molding - Scratch - Minimal / Bonnet, Headlight - Scratch - Small / Front Bumper, Grille, Lamps - Scratch - Medium / Trunk Hood, Rear Gate - Scratch - Minimal / (L) Front Fender, Molding - Scratch - Minimal / (L) Front Door, Molding - Scratch - Minimal</p>
