## General Information

<b>Make</b>	Toyota	<b>Model</b>	Fortuner
<b>YOM</b>	2023	<b>Odo Meter Reading</b>	8,671
<b>Registration No.</b>	NII2310	<b>Chassis No.</b>	MHFJB8GS7N1590062
<b>CC</b>	2.4	<b>Transmission</b>	A/T
<b>Fuel Type</b>	Diesel	<b>Type of Body</b>	SUV
<b>Colour</b>	Black

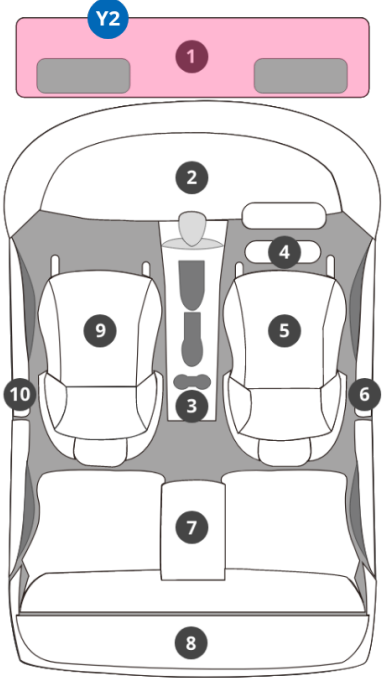
<b>Interior Evaluation :</b> <span style="float: right; color: red; font-weight: bold;">A</span>	<b>Exterior Evaluation :</b> <span style="float: right; color: red; font-weight: bold;">C</span>

<p><b>A</b> : Scratch <b>AU</b> : Scratch &amp; Dent <b>B</b> : Modified <b>C</b> : Corrosion <b>G</b> : Stone chip <b>P</b> : Faded <b>S</b> : Rust <b>SC</b> : Rust &amp; Corrosion <b>U</b> : Dent <b>X</b> : Defective <b>Y</b> : Crack, Gap</p>
<b>Remarks</b> Ceiling - Grime - Small	<b>Remarks</b> (R) Front Fender, Molding - Scratch & Dent - Minimal / (R) Mirror - Scratch - Minimal / (R) Front Door, Molding - Scratch - Small / (R) Rear Door, Molding - Scratch - Minimal / (R) Rear Fender, Molding - Scratch - Minimal / Rear Bumper, Lamps, Panels - Scratch - Small / Trunk Hood, Rear Gate - Scratch - Minimal / (L) Rear Fender, Molding - Scratch - Minimal / (L) Rear Door, Molding - Scratch & Dent - Minimal / (L) Rear Door, Molding - Repair mark - Yes / (L) Step, In-panel, Side Spoiler - Scratch & Dent - Small / (L) Mirror - Scratch - Minimal / (L) Front Door, Molding - Scratch - Minimal / (L) Front Fender, Molding - Scratch - Minimal / Front Bumper, Grille, Lamps - Scratch - Small / Bonnet, Headlight - Scratch - Minimal / Roof - Scratch & Dent - Small
