General Information

Make	Toyota	Model	Hiace
YOM	2021	Odo Meter Reading	179,070
Registration No.	NGY1198	Chassis No.	JTFNAFAP2L8019034
CC	2.8	Transmission	M/T
Fuel Type	Diesel	Type of Body	Van
Colour	White

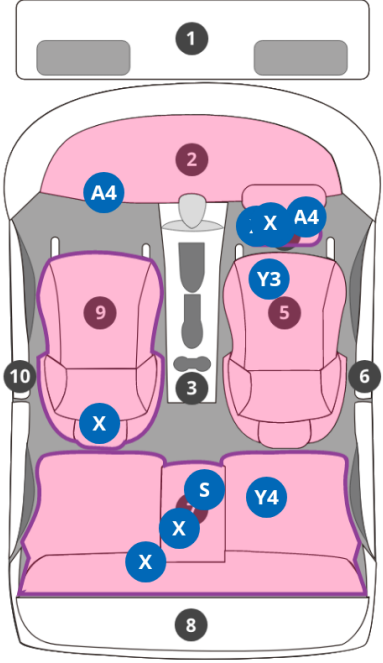
Interior Evaluation : C	Exterior Evaluation : E

<p>a : Cut, Fray d : Loose, Deformed k : Animal Hair s : Smell t : Cigarette Burns x : Defective y : Stain</p>

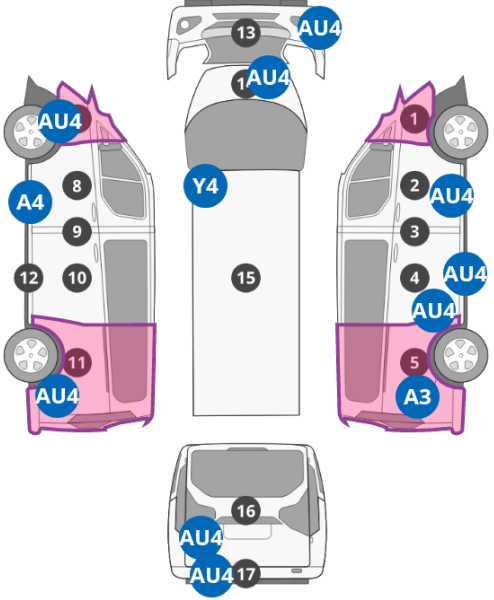
<p>A : Scratch AU : Scratch & Dent B : Modified C : Corrosion G : Stone chip P : Faded S : Rust SC : Rust & Corrosion U : Dent X : Defective Y : Crack, Gap</p>
<p>Remarks Overall Interior - Worn as per age - Yes / Carpet - Worn, Scratch, Cut, Crack - Large / Overall Interior - Smell - Yes / (R) Front Floor Mat - Missing - Yes / (L) Front Floor Mat - Missing - Yes / Mat Other - Missing - Yes / Rear Seat - Grime - Large / (R) Front Seat - Grime - Medium / Rear Seat - Partially Missing - Yes / Steering Wheel - Worn, Peel, Crack - Large / (L) Front Seat Head Rest - Missing - Yes / Rear Seat Head Rest - Missing - Yes</p>	<p>Remarks Bonnet - Repair Traces - Yes / Bonnet, Headlight - Scratch & Dent - Large / Front Bumper, Grille, Lamps - Scratch & Dent - Large / (R) Front Door, Molding - Scratch & Dent - Large / (R) Step, In-panel, Side Spoiler - Scratch & Dent - Large / (R) Rear Door, Molding - Scratch & Dent - Large / Trunk Hood, Rear Gate - Scratch & Dent - Large / Rear Bumper, Lamps, Panels - Scratch & Dent - Large / (L) Rear Fender, Molding - Scratch & Dent - Large / (L) Step, In-panel, Side Spoiler - Scratch - Large / (L) Front Fender, Molding - Scratch & Dent - Large / Front Windshield - Damaged - Large / (R) Rear Fender, Molding - Scratch - Medium / (L) Front Wheel, Cover - Cap Missing - Yes / (L) Rear Wheel, Cover - Cap Missing - Yes / (R) Front Wheel, Cover - Cap Missing - Yes / (R) Rear Wheel, Cover - Cap Missing - Yes</p>
