## General Information

| <b>Make</b> | Toyota | <b>Model</b> | Vios |
| <b>Registration No.</b> | CCA1301 | <b>Chassis No.</b> | PA1B18F34P4220464 |

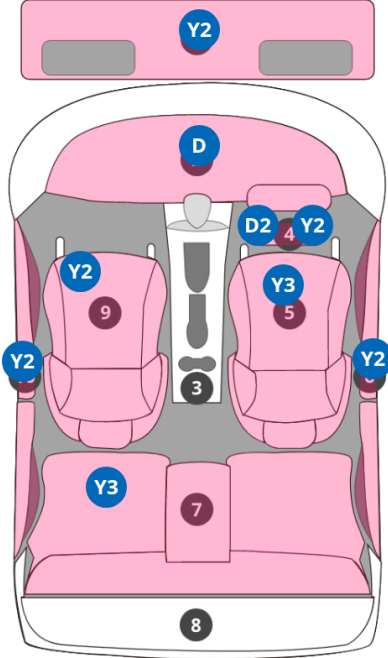
| <b>Interior Evaluation :</b> <span style="float: right; color: red; font-weight: bold;">C</span> | <b>Exterior Evaluation :</b> <span style="float: right; color: red; font-weight: bold;">B</span> |
| <p><b>Remarks</b><br/>Ceiling - Grime - Small / (R) Front Seat - Grime - Medium / (R) Front Trim - Grime - Small / (R) Front Floor Mat - Grime - Small / Rear Seat - Grime - Medium / (L) Front Trim - Grime - Small / (L) Front Seat - Grime - Small / (L) Front Floor Mat - Worked - Small / Dashboard - Traces of Adhesive Tape - Yes</p> | <p><b>Remarks</b><br/>(L) Front Door, Molding - Scratch - Small / (L) Mirror - Scratch - Minimal / (L) Front Fender, Molding - Scratch &amp; Dent - Small / (R) Front Fender, Molding - Scratch - Medium / Trunk Hood, Rear Gate - Scratch - Small / Front Bumper, Grille, Lamps - Scratch - Minimal</p> |
