## General Information

<b>Make</b>	Toyota	<b>Model</b>	Vios
<b>YOM</b>	2021	<b>Odo Meter Reading</b>	110,652
<b>Registration No.</b>	DAP3696	<b>Chassis No.</b>	PA1B18F34M4157149
<b>CC</b>	1.3	<b>Transmission</b>	CVT
<b>Fuel Type</b>	Gas	<b>Type of Body</b>	Sedan
<b>Colour</b>	Red Mica Metallic

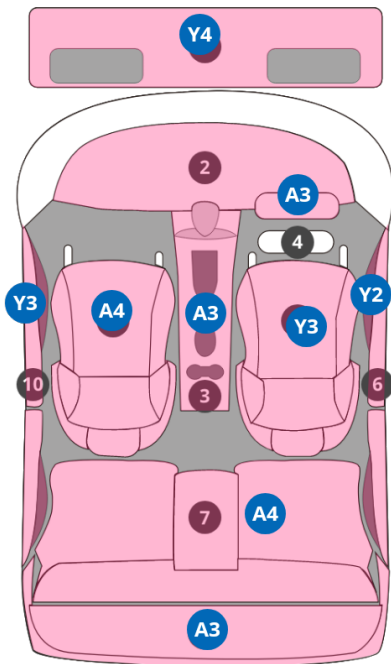
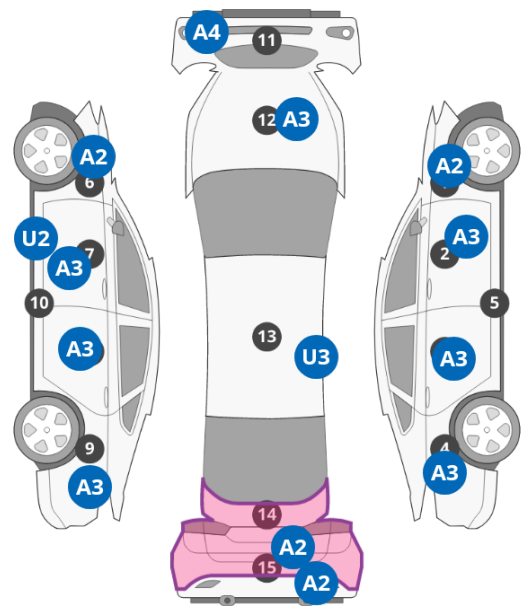
<b>Interior Evaluation :</b>	<b>E</b>	<b>Exterior Evaluation :</b>	<b>E</b>

<p><b>a</b> : Cut, Fray <b>d</b> : Loose, Deformed <b>k</b> : Animal Hair <b>s</b> : Smell <b>t</b> : Cigarette Burns <b>x</b> : Defective <b>y</b> : Stain</p>		<p><b>A</b> : Scratch <b>AU</b> : Scratch &amp; Dent <b>B</b> : Modified <b>C</b> : Corrosion <b>G</b> : Stone chip <b>P</b> : Faded <b>S</b> : Rust <b>SC</b> : Rust &amp; Corrosion <b>U</b> : Dent <b>X</b> : Defective <b>Y</b> : Crack, Gap</p>	
<p><b>Remarks</b> (R) Front Seat - Grime - Medium / (R) Front Trim - Grime - Small / Rear Seat - Cut, Crack - Large / Trunk Room - Worn, Scratch, Cut, Crack - Medium / (L) Front Trim - Grime - Medium / Steering Wheel - Worn, Peel, Crack - Medium / (L) Front Seat - Cut, Crack - Large / Ceiling - Grime - Large / Console, Switches, Vents - Worn, Scratch, Cut, Crack - Medium</p>		<p><b>Remarks</b> Trunk Hood, Rear Gate - Repair Traces - Yes / (L) Front Door, Molding - Scratch - Medium / (L) Rear Door, Molding - Scratch - Medium / (L) Rear Fender, Molding - Scratch - Medium / (R) Rear Fender, Molding - Scratch - Medium / Trunk Hood, Rear Gate - Scratch - Small / Rear Bumper, Lamps, Panels - Scratch - Small / (L) Front Fender, Molding - Scratch - Small / Front Bumper, Grille, Lamps - Scratch - Large / Bonnet, Headlight - Scratch - Medium / (R) Front Fender, Molding - Scratch - Small / Roof - Dent - Medium / (R) Front Door, Molding - Scratch - Medium / (R) Rear Door, Molding - Scratch - Medium / (L) Step, In-panel, Side Spoiler - Dent - Small / Trunk Hood, Rear Gate - Repair mark - Yes</p>
