General Information

| Make | Toyota | Model | Avanza |
| Registration No. | DBA4494 | Chassis No. | MHKM5EF2FLK024300 |

Body / Panel Condition

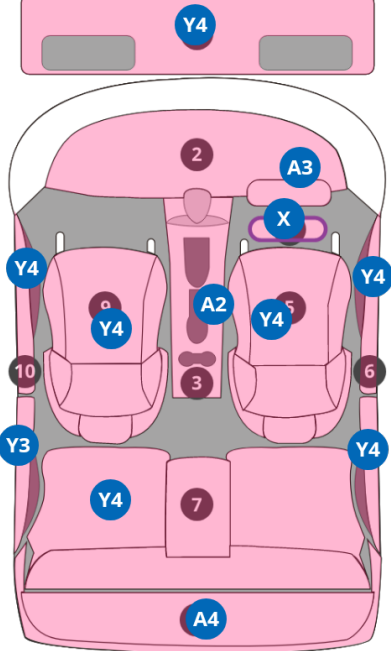
| Interior Evaluation : | E | Exterior Evaluation : | E |
| <p>Remarks Rear Seat - Grime - Large / (R) Rear Trim - Grime - Large / (R) Front Trim - Grime - Large / (R) Front Seat - Grime - Large / (R) Front Floor Mat - Missing - Yes / Trunk Room - Worn, Scratch, Cut, Crack - Large / (L) Rear Trim - Grime - Medium / (L) Front Trim - Grime - Large / (L) Front Seat - Grime - Large / Steering Wheel - Worn, Peel, Crack - Medium / Console, Switches, Vents - Worn, Scratch, Cut, Crack - Small / Ceiling - Grime - Large</p> | | <p>Remarks (R) Front Fender - Repair Traces - Yes / (L) Front Fender - Repair Traces - Yes / (R) Rear Fender - Repair Traces - Yes / Trunk Hood, Rear Gate - Scratch & Dent - Large / Rear Bumper, Lamps, Panels - Scratch & Dent - Medium / (L) Rear Fender, Molding - Scratch - Medium / (L) Rear Door, Molding - Scratch - Medium / (L) Mirror - Scratch - Small / (L) Front Fender, Molding - Dent - Medium / (L) Front Door, Molding - Scratch - Small / Front Bumper, Grille, Lamps - Scratch - Large / Bonnet, Headlight - Scratch - Small / (R) Front Fender, Molding - Scratch - Small / (R) Mirror - Scratch - Minimal / (R) Rear Door, Molding - Scratch - Medium / (R) Rear Fender, Molding - Scratch - Small / Roof - Dent - Small / (R) Step, In-panel, Side Spoiler - Dent - Medium / (R) Front Door, Molding - Scratch & Dent - Small / (R) Rear Fender, Molding - Repair mark - Yes / (R) Front Fender, Molding - Repair mark - Yes / (L) Front Fender, Molding - Repair mark - Yes</p> | |
