## General Information

Date & Time: 27, Oct, 2025 12:44

<b>Make</b>	Toyota	<b>Model</b>	Vios
<b>YOM</b>	2023	<b>Odo Meter Reading</b>	15,377
<b>Registration No.</b>	DBB6262	<b>Chassis No.</b>	PA1B18F32P4208605
<b>CC</b>	1.3	<b>Transmission</b>	CVT
<b>Fuel Type</b>	Gas	<b>Type of Body</b>	Sedan
<b>Colour</b>	Red Mica Metallic

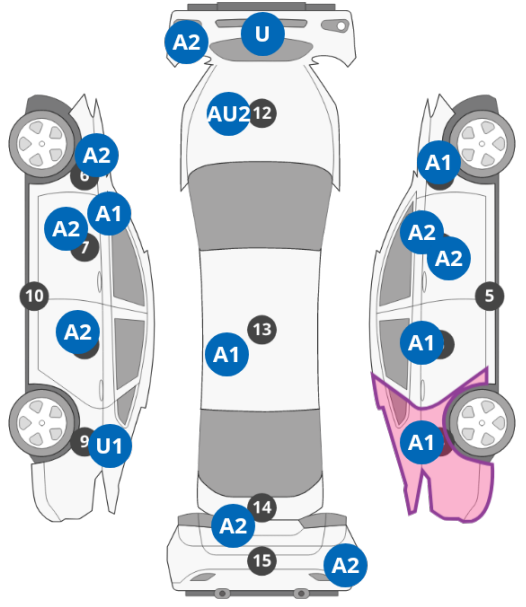
<p><b>A</b> : Scratch <b>AU</b> : Scratch &amp; Dent <b>B</b> : Modified <b>C</b> : Corrosion <b>G</b> : Stone chip <b>P</b> : Faded <b>S</b> : Rust <b>SC</b> : Rust &amp; Corrosion <b>U</b> : Dent <b>X</b> : Defective <b>Y</b> : Crack, Gap</p>
<p><b>Remarks</b> (L) Front Seat - Worn - Yes / (R) Front Seat - Grime - Medium / Rear Seat - Grime - Medium / (R) Rear Trim - Cut, Crack - Minimal / (R) Front Trim - Grime - Medium / (L) Front Trim - Grime - Small / (L) Front Floor Mat - Worked - Small / (R) Front Floor Mat - Grime - Small / Ceiling - Grime - Minimal</p>	<p><b>Remarks</b> (R) Front Fender - Repair Traces - Yes / Bonnet - Repair Traces - Yes / (L) Front Fender - Repair Traces - Yes / (L) Rear Door - Repair Traces - Yes / Trunk Hood, Rear Gate - Repair Traces - Yes / (R) Rear Door - Repair Traces - Yes / (R) Mirror - Scratch - Small / (R) Front Fender, Molding - Scratch - Minimal / (R) Front Door, Molding - Scratch - Small / (R) Rear Door, Molding - Scratch - Minimal / (R) Rear Fender, Molding - Repair mark - Yes / (R) Rear Fender, Molding - Scratch - Minimal / Rear Bumper, Lamps, Panels - Scratch - Small / Trunk Hood, Rear Gate - Scratch - Small / Overall Exterior - Faded(Color, Gloss) - Yes / (L) Rear Fender, Molding - Dent - Minimal / (L) Rear Door, Molding - Scratch - Small / (L) Front Door, Molding - Scratch - Small / (L) Mirror - Scratch - Minimal / (L) Front Fender, Molding - Scratch - Small / Member (Bolted) - Dent - Yes / Bonnet, Headlight - Scratch &amp; Dent - Small / Front Bumper, Grille, Lamps - Scratch - Small / Roof - Scratch - Minimal</p>
