## General Information

<b>Make</b>	Toyota	<b>Model</b>	Vios
<b>YOM</b>	2024	<b>Odo Meter Reading</b>	16,216
<b>Registration No.</b>	DBT4629	<b>Chassis No.</b>	PA1B18F37R4260427
<b>CC</b>	1.3	<b>Transmission</b>	CVT
<b>Fuel Type</b>	Gas	<b>Type of Body</b>	Sedan
<b>Colour</b>	Silver

## Body / Panel Condition

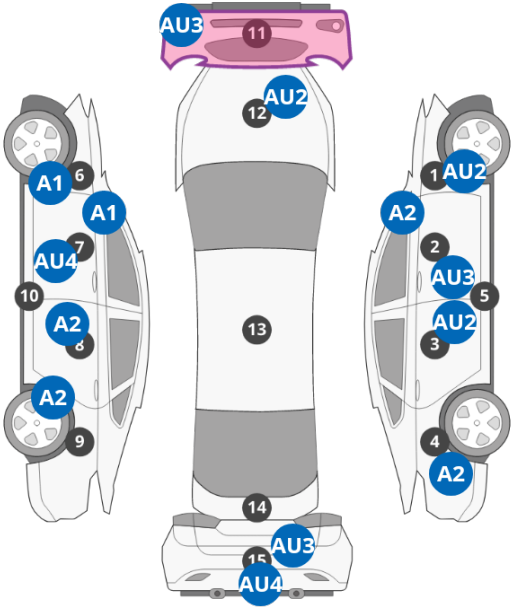
<p><b>A</b> : Scratch <b>AU</b> : Scratch &amp; Dent <b>B</b> : Modified <b>C</b> : Corrosion <b>G</b> : Stone chip <b>P</b> : Faded <b>S</b> : Rust <b>SC</b> : Rust &amp; Corrosion <b>U</b> : Dent <b>X</b> : Defective <b>Y</b> : Crack, Gap</p>
<p><b>Remarks</b> Ceiling - Grime - Medium / (R) Front Trim - Grime - Small / (R) Front Seat - Grime - Medium / (R) Front Floor Mat - Grime - Medium / Dashboard - Traces of Adhesive Tape - Yes / Mat Other - Missing - Yes / Rear Seat - Grime - Large / (L) Front Seat - Grime - Medium / (L) Front Floor Mat - Worked - Small / (L) Front Trim - Grime - Small</p>	<p><b>Remarks</b> Front Bumper, Grille, Lamps - Repair mark - Difference in Color / Front Bumper, Grille, Lamps - Scratch &amp; Dent - Medium / (L) Front Door, Molding - Scratch &amp; Dent - Large / (L) Mirror - Scratch - Minimal / (L) Rear Door, Molding - Scratch - Small / (L) Rear Fender, Molding - Scratch - Small / Trunk Hood, Rear Gate - Scratch &amp; Dent - Medium / Rear Bumper, Lamps, Panels - Scratch &amp; Dent - Large / (R) Rear Fender, Molding - Scratch - Small / (R) Front Door, Molding - Scratch &amp; Dent - Medium / (R) Rear Door, Molding - Scratch &amp; Dent - Small / (R) Mirror - Scratch - Small / (R) Front Fender, Molding - Scratch &amp; Dent - Small / Bonnet, Headlight - Scratch &amp; Dent - Small / (L) Front Fender, Molding - Scratch - Minimal</p>
