General Information

Make	Toyota	Model	Hiace
YOM	2019	Odo Meter Reading	92,126
Registration No.	NDN5773	Chassis No.	JTFNAFAP8K8008814
CC	2.8	Transmission	M/T
Fuel Type	Diesel	Type of Body	SUV
Colour	Silver

Body / Panel Condition

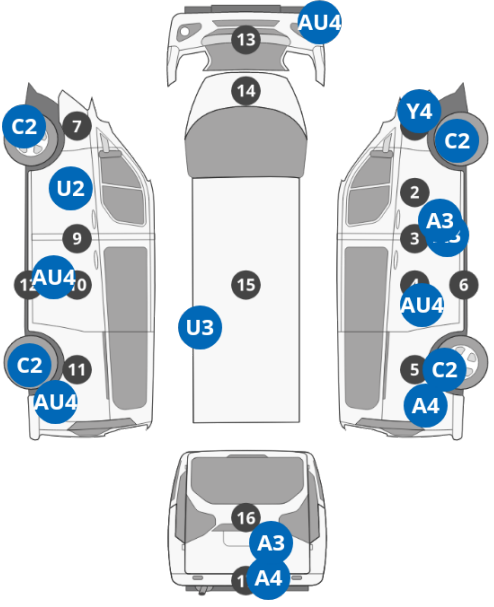
</div> <p>A : Scratch AU : Scratch & Dent B : Modified C : Corrosion G : Stone chip P : Faded S : Rust SC : Rust & Corrosion U : Dent X : Defective Y : Crack, Gap</p>
<p>Remarks Overall Interior - Worn as per age - Yes / Overall Interior - Smell - Yes / (R) Front Seat - Grime - Large</p>	<p>Remarks (R) Front Door - Repair Traces - Yes / (R) Step - Repair Traces - Yes / Bonnet - Repair Traces - Yes / (L) Front Fender - Repair Traces - Yes / (L) Front Door - Repair Traces - Yes / (L) Step - Repair Traces - Yes / Trunk Hood, Rear Gate - Repair Traces - Yes / (R) Center Panel - Repair Traces - Yes / (R) Rear Door, Molding - Scratch & Dent - Large / (R) Center Panel - Scratch - Medium / (R) Front Door, Molding - Scratch - Medium / (R) Front Fender, Molding - Crack, Gap - Large / Front Bumper, Grille, Lamps - Scratch & Dent - Large / (R) Rear Wheel, Cover - Scratch, Corrosion - Small / (R) Front Wheel, Cover - Scratch, Corrosion - Small / (L) Front Wheel, Cover - Scratch, Corrosion - Small / (L) Rear Wheel, Cover - Scratch, Corrosion - Small / (L) Front Door, Molding - Dent - Small / (L) Rear Door, Molding - Scratch & Dent - Large / (L) Rear Fender, Molding - Scratch & Dent - Large / Rear Bumper, Lamps, Panels - Scratch - Large / (R) Rear Fender, Molding - Scratch - Large / Trunk Hood, Rear Gate - Scratch - Medium / Roof - Dent - Medium</p>
