## General Information

Date & Time: 24, Oct, 2025 15:27

<b>Make</b>	Toyota	<b>Model</b>	Vios
<b>YOM</b>	2023	<b>Odo Meter Reading</b>	22,056
<b>Registration No.</b>	NFB7196	<b>Chassis No.</b>	PA1B18F38P4218331
<b>CC</b>	1.3	<b>Transmission</b>	CVT
<b>Fuel Type</b>	Gas	<b>Type of Body</b>	Sedan
<b>Colour</b>	Silver

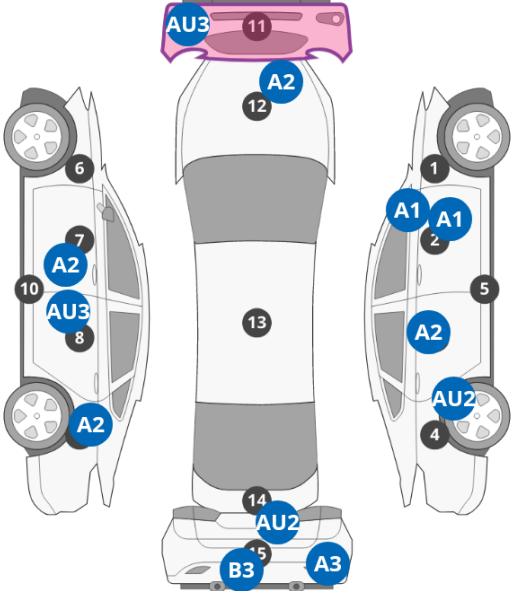
<p><b>A</b> : Scratch <b>AU</b> : Scratch &amp; Dent <b>B</b> : Modified <b>C</b> : Corrosion <b>G</b> : Stone chip <b>P</b> : Faded <b>S</b> : Rust <b>SC</b> : Rust &amp; Corrosion <b>U</b> : Dent <b>X</b> : Defective <b>Y</b> : Crack, Gap</p>
<p><b>Remarks</b> Ceiling - Grime - Medium / (R) Front Trim - Grime - Small / Console, Switches, Vents - Traces of Adhesive Tape - Yes / (R) Front Seat - Grime - Medium / Rear Seat - Grime - Medium / (L) Front Trim - Grime - Small / (L) Front Floor Mat - Worked - Small / (L) Front Seat - Grime - Small</p>	<p><b>Remarks</b> (R) Rear Door, Molding - Scratch - Small / (R) Mirror - Scratch - Minimal / (R) Front Door, Molding - Scratch - Minimal / (R) Rear Fender, Molding - Scratch &amp; Dent - Small / Rear Bumper, Lamps, Panels - Modified - Medium / Rear Bumper, Lamps, Panels - Scratch - Medium / Trunk Hood, Rear Gate - Scratch &amp; Dent - Small / (L) Rear Fender, Molding - Scratch - Small / (L) Rear Door, Molding - Scratch &amp; Dent - Medium / (L) Front Door, Molding - Scratch - Small / Bonnet, Headlight - Scratch - Small / Front Bumper, Grille, Lamps - Repair mark - Yes / Front Bumper, Grille, Lamps - Scratch &amp; Dent - Medium</p>
