General Information

| Make | Toyota | Model | Vios |
| YOM | 2023 | Odo Meter Reading | 65,010 |
| Registration No. | NHA4661 | Chassis No. | PA1B18F36P4223365 |

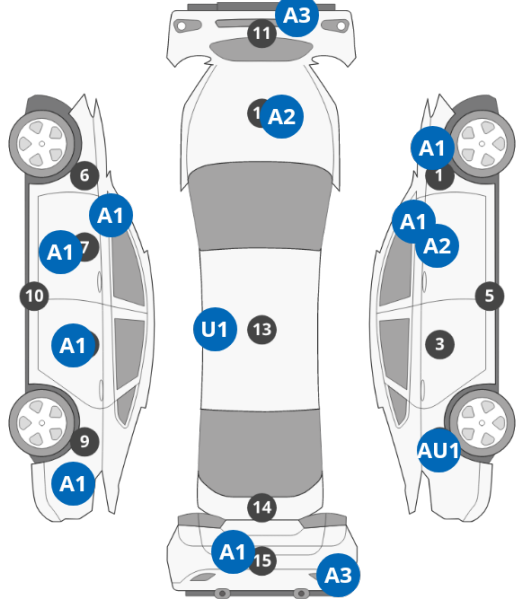
| Interior Evaluation : E | Exterior Evaluation : B |
| <p>Remarks Rear Seat - Grime - Large / (R) Rear Trim - Grime - Small / (R) Front Trim - Grime - Medium / (R) Front Seat - Grime - Large / (L) Rear Trim - Grime - Minimal / Console, Switchs, Vents - Worn, Scratch, Cut, Crack - Medium / (L) Front Seat - Grime - Medium / (L) Front Trim - Grime - Medium / Steering Wheel - Worn, Peel, Crack - Medium / Ceiling - Grime - Medium / Trunk Room - Worn, Scratch, Cut, Crack - Small</p> | <p>Remarks (R) Front Fender - Repair Traces - Yes / Bonnet - Repair Traces - Yes / (L) Front Fender - Repair Traces - Yes / (L) Rear Fender - Repair Traces - Yes / Trunk Hood, Rear Gate - Repair Traces - Yes / Roof - Repair Traces - Yes / Roof - Dent - Minimal / Trunk Hood, Rear Gate - Scratch - Minimal / Rear Bumper, Lamps, Panels - Scratch - Medium / (R) Rear Fender, Molding - Scratch & Dent - Minimal / (R) Front Door, Molding - Scratch - Small / (R) Mirror - Scratch - Minimal / (R) Front Fender, Molding - Scratch - Minimal / Front Bumper, Grille, Lamps - Scratch - Medium / Bonnet, Headlight - Scratch - Small / (L) Mirror - Scratch - Minimal / (L) Front Door, Molding - Scratch - Minimal / (L) Rear Door, Molding - Scratch - Minimal / (L) Rear Fender, Molding - Scratch - Minimal</p> |
