General Information

| Make | Toyota | Model | Avanza |
| Registration No. | NHJ4732 | Chassis No. | MHFAA1BY0P0015705 |

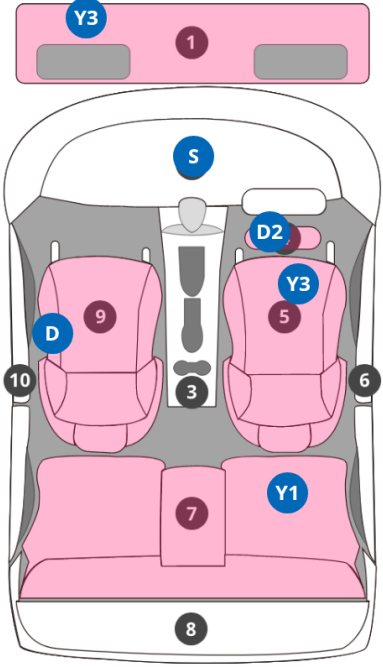
| Interior Evaluation : B | Exterior Evaluation : E |
| <p>Remarks Overall Interior - Smell - Yes / (R) Front Seat - Grime - Medium / (L) Front Seat - Worn - Yes / Rear Seat - Grime - Minimal / (L) Front Floor Mat - Worked - Small / Ceiling - Grime - Medium</p> | <p>Remarks (R) Front Door - Repair Traces - Yes / (R) Front Fender - Repair Traces - Yes / Bonnet - Repair Traces - Yes / (L) Front Fender - Repair Traces - Yes / (L) Rear Door - Repair Traces - Yes / (R) Mirror - Scratch - Small / Front Windshield - Scratch, Stone chip - Large / (R) Front Fender, Molding - Scratch - Minimal / (R) Step, In-panel, Side Spoiler - Scratch - Small / (R) Front Door, Molding - Scratch - Minimal / (R) Rear Door, Molding - Scratch & Dent - Small / (R) Rear Fender, Molding - Scratch - Small / Rear Bumper, Lamps, Panels - Scratch - Medium / Trunk Hood, Rear Gate - Scratch & Dent - Small / (L) Rear Fender, Molding - Scratch & Dent - Small / (L) Step, In-panel, Side Spoiler - Scratch & Dent - Medium / (L) Rear Door, Molding - Scratch & Dent - Medium / (L) Front Door, Molding - Crack, Gap - Large / (L) Mirror - Scratch - Minimal / (L) Front Fender, Molding - Scratch - Minimal / Front Bumper, Grille, Lamps - Repair mark - Yes / Front Bumper, Grille, Lamps - Scratch - Small / Bonnet, Headlight - Scratch - Large / Roof - Rust, Corrosion - Small</p> |
