## General Information

Date & Time: 24, Oct, 2025 10:49

<b>Make</b>	Toyota	<b>Model</b>	Avanza
<b>YOM</b>	2023	<b>Odo Meter Reading</b>	65,766
<b>Registration No.</b>	NIN8117	<b>Chassis No.</b>	MHFAA1BY4P0014668
<b>CC</b>	1.3	<b>Transmission</b>	CVT
<b>Fuel Type</b>	Gas	<b>Type of Body</b>	Sedan
<b>Colour</b>	Green

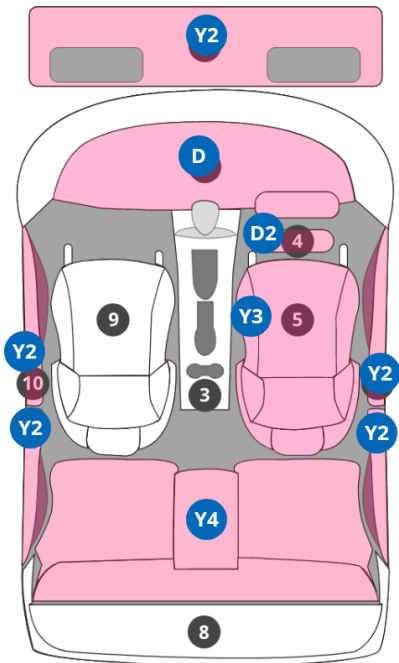
<b>Interior Evaluation :</b> <span style="float: right; color: red; font-weight: bold;">C</span>	<b>Exterior Evaluation :</b> <span style="float: right; color: red; font-weight: bold;">D</span>

<p><b>a</b> : Cut, Fray <b>d</b> : Loose, Deformed <b>k</b> : Animal Hair <b>s</b> : Smell <b>t</b> : Cigarette Burns <b>x</b> : Defective <b>y</b> : Stain</p>

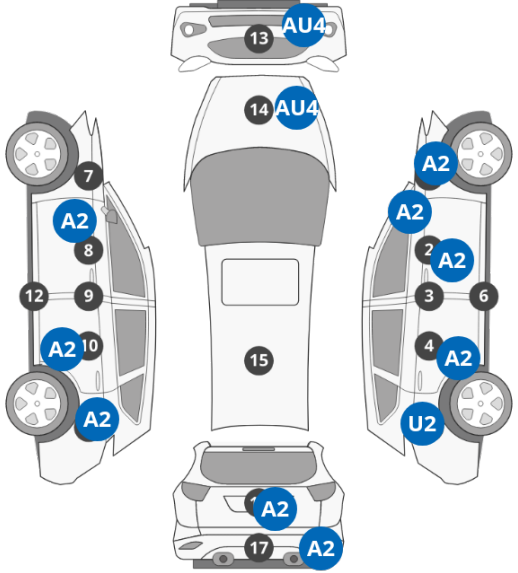
<p><b>A</b> : Scratch <b>AU</b> : Scratch &amp; Dent <b>B</b> : Modified <b>C</b> : Corrosion <b>G</b> : Stone chip <b>P</b> : Faded <b>S</b> : Rust <b>SC</b> : Rust &amp; Corrosion <b>U</b> : Dent <b>X</b> : Defective <b>Y</b> : Crack, Gap</p>
<p><b>Remarks</b> Ceiling - Grime - Small / (R) Front Trim - Grime - Small / (R) Front Seat - Grime - Medium / Dashboard - Traces of Adhesive Tape - Yes / Rear Seat - Grime - Large / (R) Rear Trim - Grime - Small / (L) Rear Trim - Grime - Small / (L) Front Trim - Grime - Small / (L) Front Floor Mat - Worked - Small</p>	<p><b>Remarks</b> (L) Rear Door, Molding - Scratch - Small / (L) Front Door, Molding - Scratch - Small / (L) Rear Fender, Molding - Scratch - Small / (R) Rear Fender, Molding - Dent - Small / (R) Rear Door, Molding - Scratch - Small / (R) Mirror - Scratch - Small / (R) Front Door, Molding - Scratch - Small / (R) Front Fender, Molding - Scratch - Small / Bonnet, Headlight - Scratch &amp; Dent - Large / Front Bumper, Grille, Lamps - Scratch &amp; Dent - Large / Rear Bumper, Lamps, Panels - Scratch - Small / Trunk Hood, Rear Gate - Scratch - Small</p>
