General Information

Date & Time: 27, Oct, 2025 17:10

Make	Toyota	Model	86
YOM	2016	Odo Meter Reading	29,921
Registration No.	ABQ9563	Chassis No.	JF1ZN6L81GG023803
CC	2.0	Transmission	M/T
Fuel Type	Gas	Type of Body	Coupe
Colour	White

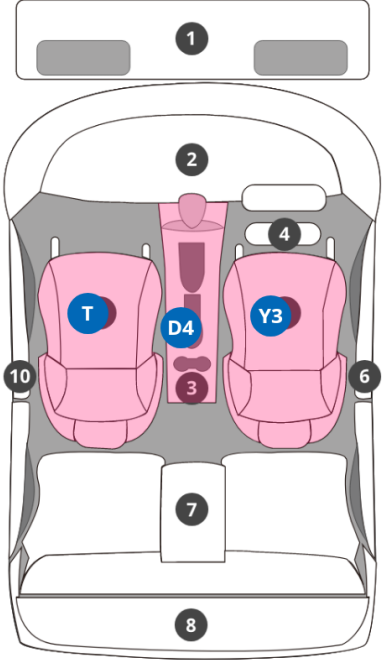
Interior Evaluation : C	Exterior Evaluation : B

<p>a : Cut, Fray d : Loose, Deformed k : Animal Hair s : Smell t : Cigarette Burns x : Defective y : Stain</p>

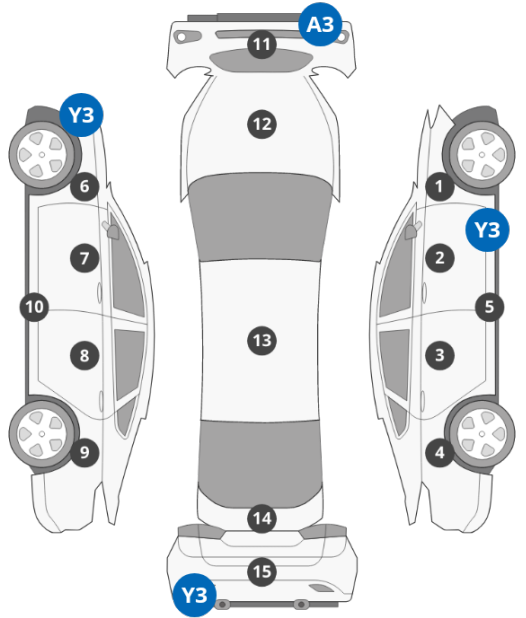
<p>A : Scratch AU : Scratch & Dent B : Modified C : Corrosion G : Stone chip P : Faded S : Rust SC : Rust & Corrosion U : Dent X : Defective Y : Crack, Gap</p>
<p>Remarks (R) Front Seat - Grime - Medium / Console, Switches, Vents - Loose, Deformed - Large / (L) Front Seat - Cigarette Burns - Burnt, Hole</p>	<p>Remarks (R) Front Door - Repair Traces - Yes / (R) Front Fender - Repair Traces - Yes / Bonnet - Repair Traces - Yes / (L) Front Fender - Repair Traces - Yes / (L) Rear Fender - Repair Traces - Yes / Trunk Hood, Rear Gate - Repair Traces - Yes / (R) Rear Fender - Repair Traces - Yes / Roof - Repair Traces - Yes / (L) Front Fender, Molding - Crack, Gap - Medium / Front Bumper, Grille, Lamps - Scratch - Medium / (R) Step, In-panel, Side Spoiler - Crack, Gap - Medium / Rear Bumper, Lamps, Panels - Crack, Gap - Medium</p>
