General Information

Make	Mitsubishi	Model	Mirage
YOM	2022	Odo Meter Reading	42,339
Registration No.	LAJ3914	Chassis No.	PAEA13RJNM022043
CC	1.2	Transmission	A/T
Fuel Type	Gas	Type of Body	Sedan
Colour	Red

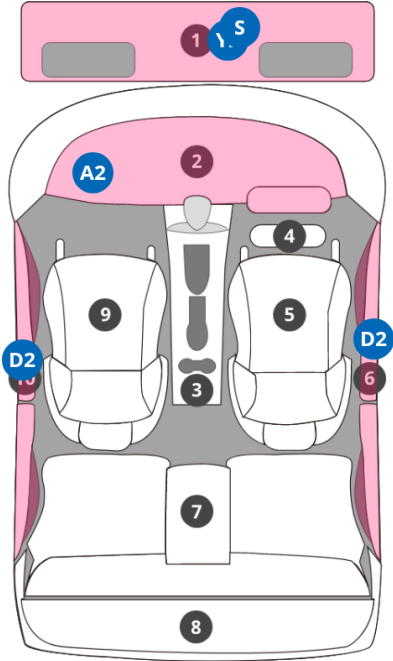
Interior Evaluation : B	Exterior Evaluation : E

<p>a : Cut, Fray d : Loose, Deformed k : Animal Hair s : Smell t : Cigarette Burns x : Defective y : Stain</p>

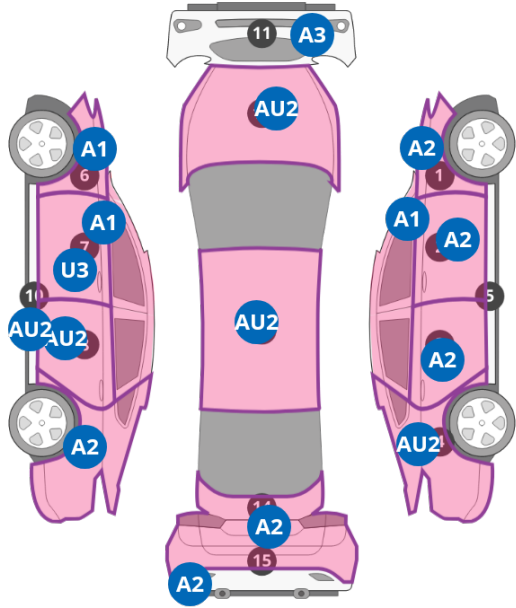
<p>A : Scratch AU : Scratch & Dent B : Modified C : Corrosion G : Stone chip P : Faded S : Rust SC : Rust & Corrosion U : Dent X : Defective Y : Crack, Gap</p>
<p>Remarks Ceiling - Grime - Small / Overall Interior - Smell - Yes / Steering Wheel - Worn, Peel, Crack - Small / (L) Front Trim - Worked - Small / (R) Front Trim - Worked - Small</p>	<p>Remarks (R) Front Door - Repair Traces - Yes / (R) Step - Repair Traces - Yes / (R) Front Fender - Repair Traces - Yes / Bonnet - Repair Traces - Yes / (L) Front Fender - Repair Traces - Yes / (L) Front Door - Repair Traces - Yes / (L) Step - Repair Traces - Yes / (L) Rear Door - Repair Traces - Yes / (R) Rear Fender - Repair Traces - Yes / (R) Rear Door - Repair Traces - Yes / (R) Front Door, Molding - Repair mark - Yes / (R) Rear Door, Molding - Repair mark - Yes / (R) Rear Fender, Molding - Repair mark - Yes / Trunk Hood, Rear Gate - Repair mark - Yes / (L) Rear Fender, Molding - Repair mark - Yes / (L) Rear Door, Molding - Repair mark - Yes / (L) Front Door, Molding - Repair mark - Yes / (L) Front Fender, Molding - Repair mark - Yes / Bonnet, Headlight - Repair mark - Yes / (R) Front Fender, Molding - Repair mark - Yes / Roof - Repair mark - Yes / (L) Front Door, Molding - Dent - Medium / (L) Mirror - Scratch - Minimal / (L) Front Fender, Molding - Scratch - Minimal / (L) Rear Door, Molding - Scratch & Dent - Small / (L) Rear Fender, Molding - Scratch - Small / (L) Step, In-panel, Side Spoiler - Scratch & Dent - Small / Front Bumper, Grille, Lamps - Scratch - Medium / Bonnet, Headlight - Scratch & Dent - Small / (R) Front Fender, Molding - Scratch - Small / (R) Front Door, Molding - Scratch - Small / (R) Rear Door, Molding - Scratch - Small / (R) Rear Fender, Molding - Scratch & Dent - Small / (R) Mirror - Scratch - Minimal / Trunk Hood, Rear Gate - Scratch - Small / Rear Bumper, Lamps, Panels - Scratch - Small / Roof - Scratch & Dent - Small</p>
