## General Information

Date & Time: 25, Oct, 2025 15:56

<b>Make</b>	Suzuki	<b>Model</b>	Dzire
<b>YOM</b>	2024	<b>Odo Meter Reading</b>	23,337
<b>Registration No.</b>	LAM1993	<b>Chassis No.</b>	MBHZF63S7R441984
<b>CC</b>	1.2	<b>Transmission</b>	CVT
<b>Fuel Type</b>	Gas	<b>Type of Body</b>	Sedan
<b>Colour</b>	Brown

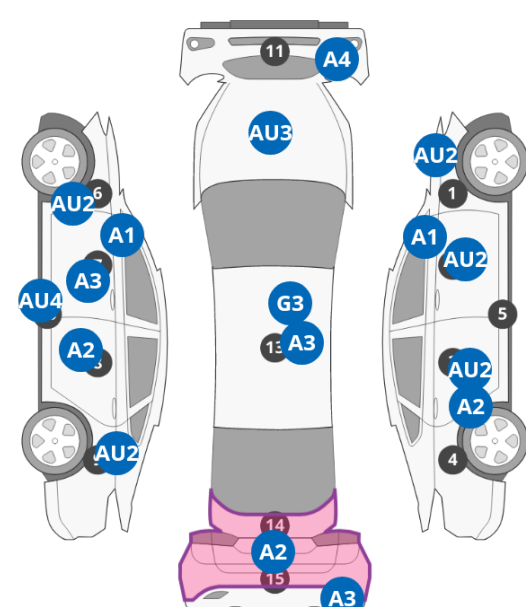
<p><b>A</b> : Scratch <b>AU</b> : Scratch &amp; Dent <b>B</b> : Modified <b>C</b> : Corrosion <b>G</b> : Stone chip <b>P</b> : Faded <b>S</b> : Rust <b>SC</b> : Rust &amp; Corrosion <b>U</b> : Dent <b>X</b> : Defective <b>Y</b> : Crack, Gap</p>
<p><b>Remarks</b> Overall Interior - Smell - Yes / (L) Front Floor Mat - Worked - Small / (R) Front Floor Mat - Grime - Small / (L) Front Trim - Grime - Small / (R) Front Trim - Grime - Minimal / (L) Front Seat - Grime - Small / (R) Front Seat - Grime - Small / Rear Seat - Grime - Small</p>	<p><b>Remarks</b> Trunk Hood, Rear Gate - Repair Traces - Yes / (L) Step, In-panel, Side Spoiler - Scratch &amp; Dent - Large / Trunk Hood, Rear Gate - Repair mark - Yes / (L) Rear Door, Molding - Scratch - Small / (L) Mirror - Scratch - Minimal / (L) Front Fender, Molding - Scratch &amp; Dent - Small / Front Bumper, Grille, Lamps - Scratch - Large / Bonnet, Headlight - Scratch &amp; Dent - Medium / (R) Mirror - Scratch - Minimal / (R) Front Fender, Molding - Scratch &amp; Dent - Small / (R) Front Door, Molding - Scratch &amp; Dent - Small / (R) Rear Door, Molding - Scratch &amp; Dent - Small / (R) Rear Fender, Molding - Scratch - Small / Rear Bumper, Lamps, Panels - Scratch - Medium / Trunk Hood, Rear Gate - Scratch - Small / (L) Front Door, Molding - Scratch - Medium / Roof - Scratch - Medium / (L) Rear Fender, Molding - Scratch &amp; Dent - Small / Front Windshield - Scratch, Stone chip - Medium</p>
