## General Information

<b>Make</b>	Mazda	<b>Model</b>	Mazda 2
<b>YOM</b>	2018	<b>Odo Meter Reading</b>	25,228
<b>Registration No.</b>	NAI9099	<b>Chassis No.</b>	MM7DL2SAAJW322874
<b>CC</b>	1.5	<b>Transmission</b>	A/T
<b>Fuel Type</b>	Gas	<b>Type of Body</b>	Sedan
<b>Colour</b>	White

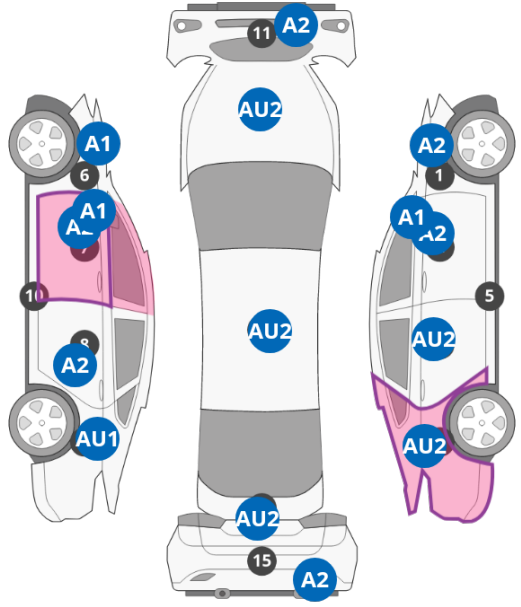
<p><b>A</b> : Scratch <b>AU</b> : Scratch &amp; Dent <b>B</b> : Modified <b>C</b> : Corrosion <b>G</b> : Stone chip <b>P</b> : Faded <b>S</b> : Rust <b>SC</b> : Rust &amp; Corrosion <b>U</b> : Dent <b>X</b> : Defective <b>Y</b> : Crack, Gap</p>
<p><b>Remarks</b> (L) Front Trim - Grime - Minimal / (R) Front Trim - Grime - Minimal / Overall Interior - Smell - Yes / Overall Interior - Worn as per age - Yes / Ceiling - Crinkle - Small</p>	<p><b>Remarks</b> (R) Rear Fender - Repair Traces - Yes / (R) Rear Fender, Molding - Repair mark - Yes / (R) Front Fender, Molding - Scratch - Small / (R) Front Door, Molding - Scratch - Small / (R) Mirror - Scratch - Minimal / (R) Rear Door, Molding - Scratch &amp; Dent - Small / (R) Rear Fender, Molding - Scratch &amp; Dent - Small / Rear Bumper, Lamps, Panels - Scratch - Small / Trunk Hood, Rear Gate - Scratch &amp; Dent - Small / (L) Front Door, Molding - Repair mark - Yes / (L) Rear Door, Molding - Scratch - Small / (L) Rear Fender, Molding - Scratch &amp; Dent - Minimal / (L) Front Door, Molding - Scratch - Small / (L) Mirror - Scratch - Minimal / (L) Front Fender, Molding - Scratch - Minimal / Bonnet, Headlight - Scratch &amp; Dent - Small / Front Bumper, Grille, Lamps - Scratch - Small / Roof - Scratch &amp; Dent - Small</p>
