General Information

Make	Suzuki	Model	Carry
YOM	2021	Odo Meter Reading	74,792
Registration No.	NEM2336	Chassis No.	NHYHDC61TMJ908094
CC	1.5	Transmission	M/T
Fuel Type	Gas	Type of Body	Van
Colour	White

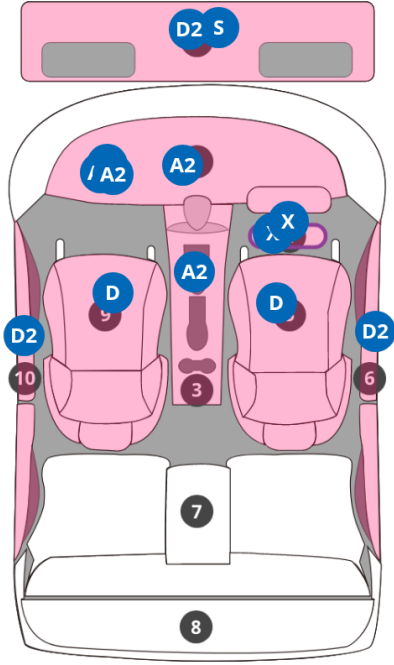
Interior Evaluation : C	Exterior Evaluation : E

<p>a : Cut, Fray d : Loose, Deformed k : Animal Hair s : Smell t : Cigarette Burns x : Defective y : Stain</p>

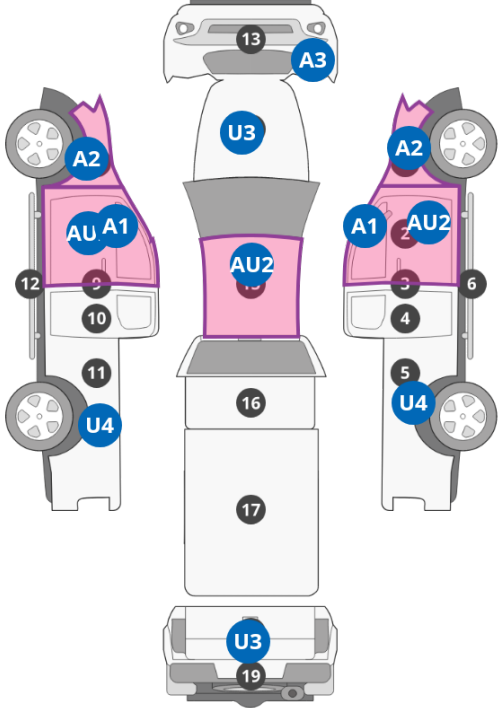
<p>A : Scratch AU : Scratch & Dent B : Modified C : Corrosion G : Stone chip P : Faded S : Rust SC : Rust & Corrosion U : Dent X : Defective Y : Crack, Gap</p>
<p>Remarks Overall Interior - Worn as per age - Yes / Overall Interior - Smell - Yes / (L) Front Floor Mat - Missing - Yes / (R) Front Floor Mat - Missing - Yes / Dashboard - Worn, Scratch, Cut, Crack - Small / Glove Box - Loose, Deformed - Small / Instrument Panel - Worn, Scratch, Cut, Crack - Minimal / Steering Wheel - Worn, Peel, Crack - Small / Console, Switches, Vents - Worn, Scratch, Cut, Crack - Small / (L) Front Seat - Worn - Yes / (R) Front Seat - Worn - Yes / (L) Front Trim - Loose, Deformed - Small / (R) Front Trim - Loose, Deformed - Small / Ceiling - Loose, Deformed - Small</p>	<p>Remarks Front Panel - Repair Traces - Yes / (L) Rear Corner Panel - Repair Traces - Yes / (R) Rear Corner Panel - Repair Traces - Yes / Roof - Repair Traces - Yes / Roof - Repair mark - Yes / (R) Front Door, Molding - Repair mark - Yes / (R) Front Fender, Molding - Repair mark - Yes / (L) Front Fender, Molding - Repair mark - Yes / (L) Front Door, Molding - Repair mark - Yes / Front Panel - Dent - Medium / Front Bumper, Grille, Lamps - Scratch - Medium / Roof - Scratch & Dent - Small / (R) Front Fender, Molding - Scratch - Small / (R) Front Door, Molding - Scratch & Dent - Small / (L) Front Door, Molding - Scratch & Dent - Small / (L) Front Fender, Molding - Scratch - Small / (L) Mirror - Scratch - Minimal / (R) Mirror - Scratch - Minimal / (L) Side Gate - Dent - Large / Rear Gate - Dent - Medium / (R) Side Gate - Dent - Large</p>
