General Information

Make	Subaru	Model	XV
YOM	2016	Odo Meter Reading	81,648
Registration No.	NCF3617	Chassis No.	JF1GP7LC5GG258034
CC	2.0	Transmission	A/T
Fuel Type	Gas	Type of Body	SUV
Colour	White

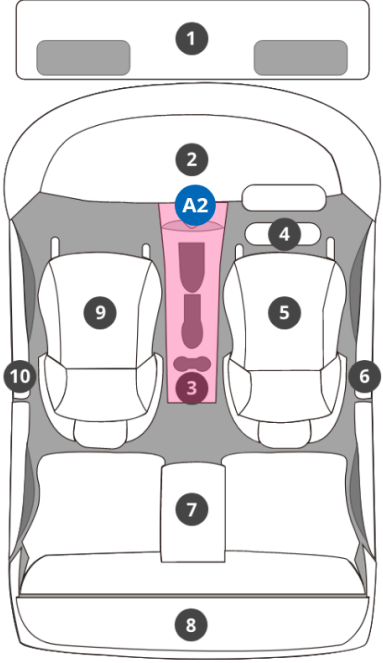
<p>a : Cut, Fray d : Loose, Deformed k : Animal Hair s : Smell t : Cigarette Burns x : Defective y : Stain</p>		<p>A : Scratch AU : Scratch & Dent B : Modified C : Corrosion G : Stone chip P : Faded S : Rust SC : Rust & Corrosion U : Dent X : Defective Y : Crack, Gap</p>	
<p>Remarks Knobs - Worn, Peel, Crack - Small</p>		<p>Remarks (R) Front Door - Repair Traces - Yes / (R) Front Fender - Repair Traces - Yes / Bonnet - Repair Traces - Yes / (L) Front Door - Repair Traces - Yes / (L) Rear Door - Repair Traces - Yes / (L) Rear Fender - Repair Traces - Yes / Trunk Hood, Rear Gate - Repair Traces - Yes / (R) Rear Door - Repair Traces - Yes / Roof - Repair Traces - Yes / (R) Mirror - Scratch, Peeled - Yes / (R) Front Fender, Molding - Repair mark - Yes / (R) Rear Door, Molding - Scratch & Dent - Medium / (R) Rear Fender, Molding - Scratch & Dent - Medium / Rear Bumper, Lamps, Panels - Scratch - Small / (L) Rear Door, Molding - Scratch - Small / (L) Front Door, Molding - Scratch - Minimal / Front Bumper, Grille, Lamps - Scratch & Dent - Large / Overall Exterior - Full Re-Paint in same color - Yes</p>
