## General Information

<b>Make</b>	Toyota	<b>Model</b>	Veloz
<b>YOM</b>	2025	<b>Odo Meter Reading</b>	6,866
<b>Registration No.</b>	NKL7628	<b>Chassis No.</b>	MHFAB1BY9R3128258
<b>CC</b>	1.5	<b>Transmission</b>	CVT
<b>Fuel Type</b>	Gas	<b>Type of Body</b>	Wagon
<b>Colour</b>	White

## Body / Panel Condition

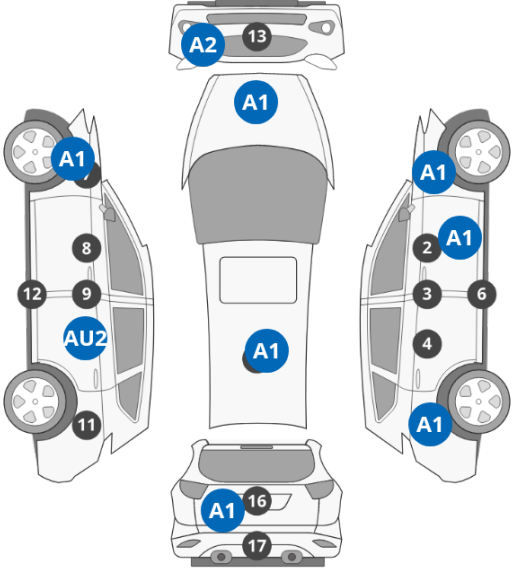
<p><b>A</b> : Scratch <b>AU</b> : Scratch &amp; Dent <b>B</b> : Modified <b>C</b> : Corrosion <b>G</b> : Stone chip <b>P</b> : Faded <b>S</b> : Rust <b>SC</b> : Rust &amp; Corrosion <b>U</b> : Dent <b>X</b> : Defective <b>Y</b> : Crack, Gap</p>
<b>Remarks</b> Rear Seat - Missing - Yes	<b>Remarks</b> (R) Rear Fender, Molding - Scratch - Minimal / (R) Front Door, Molding - Scratch - Minimal / (R) Front Fender, Molding - Scratch - Minimal / (L) Rear Door, Molding - Scratch & Dent - Small / Trunk Hood, Rear Gate - Scratch - Minimal / Roof - Scratch - Minimal / Bonnet, Headlight - Scratch - Minimal / Front Bumper, Grille, Lamps - Scratch - Small / (L) Front Fender, Molding - Scratch - Minimal
