## General Information

<b>Make</b>	Toyota	<b>Model</b>	Vios
<b>YOM</b>	2024	<b>Odo Meter Reading</b>	30,153
<b>Registration No.</b>	CCD1975	<b>Chassis No.</b>	PA1B18F37R4244843
<b>CC</b>	1.3	<b>Transmission</b>	CVT
<b>Fuel Type</b>	Gas	<b>Type of Body</b>	Sedan
<b>Colour</b>	Silver

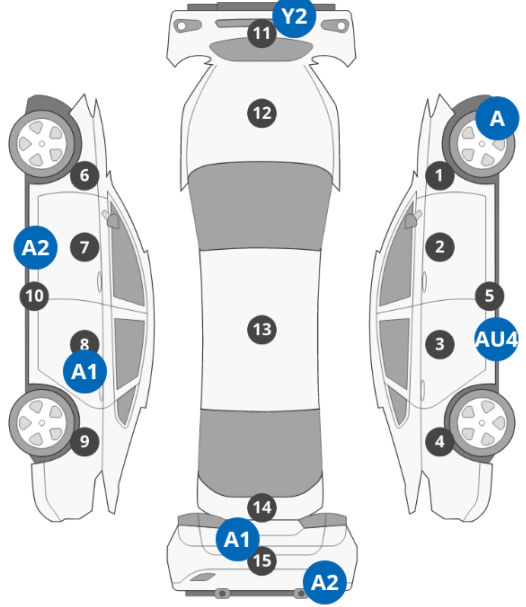
<p><b>A</b> : Scratch <b>AU</b> : Scratch &amp; Dent <b>B</b> : Modified <b>C</b> : Corrosion <b>G</b> : Stone chip <b>P</b> : Faded <b>S</b> : Rust <b>SC</b> : Rust &amp; Corrosion <b>U</b> : Dent <b>X</b> : Defective <b>Y</b> : Crack, Gap</p>
<p><b>Remarks</b> Ceiling - Grime - Medium / (R) Front Floor Mat - Missing - Yes / (L) Front Floor Mat - Missing - Yes / Mat Other - Missing - Yes / Trunk Room - Loose, Deformed - Medium</p>	<p><b>Remarks</b> (R) Step, In-panel, Side Spoiler - Scratch &amp; Dent - Large / Rear Bumper, Lamps, Panels - Scratch - Small / Trunk Hood, Rear Gate - Scratch - Minimal / (L) Rear Door, Molding - Scratch - Minimal / (R) Front Tyre - Crack, Cut - Yes / (L) Step, In-panel, Side Spoiler - Scratch - Small / Front Bumper, Grille, Lamps - Crack, Gap - Small</p>
