General Information

Date & Time: 28, Oct, 2025 15:41

Make	Isuzu	Model	Crosswind
YOM	2017	Odo Meter Reading	132,528
Registration No.	NAI8570	Chassis No.	PABTBR54FH2094931
CC	2.5	Transmission	M/T
Fuel Type	Diesel	Type of Body	Wagon
Colour	White

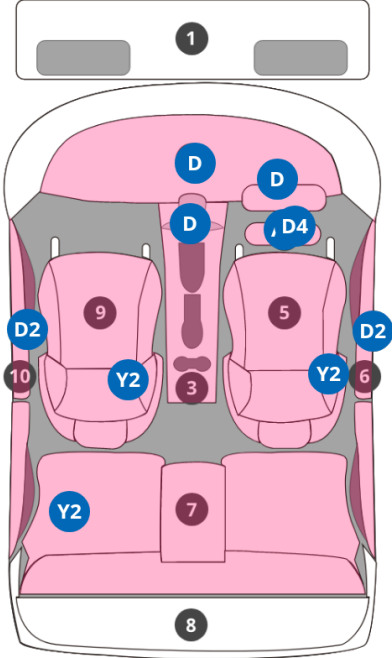
Interior Evaluation : C	Exterior Evaluation : E

<p>a : Cut, Fray d : Loose, Deformed k : Animal Hair s : Smell t : Cigarette Burns x : Defective y : Stain</p>

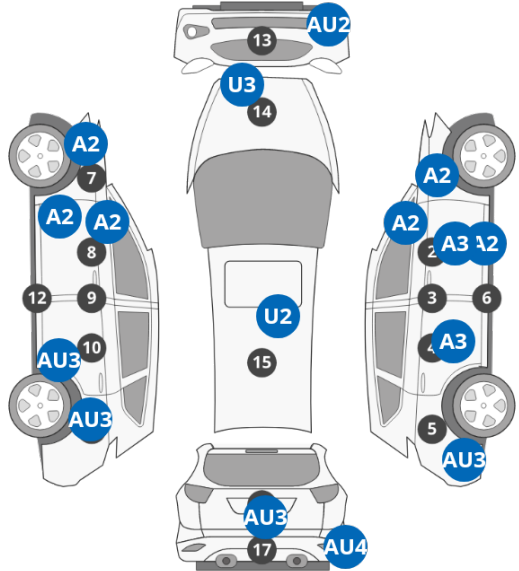
<p>A : Scratch AU : Scratch & Dent B : Modified C : Corrosion G : Stone chip P : Faded S : Rust SC : Rust & Corrosion U : Dent X : Defective Y : Crack, Gap</p>
<p>Remarks Overall Interior - Worn as per age - Yes / Rear Seat - Grime - Small / (R) Front Trim - Worked - Small / (L) Front Trim - Worked - Small / (R) Front Seat - Grime - Small / (L) Front Seat - Grime - Small / Glove Box - Traces of Adhesive Tape - Yes / Console, Switchs, Vents - Traces of Adhesive Tape - Yes / Dashboard - Traces of Adhesive Tape - Yes / (L) Front Floor Mat - Cut, Crack - Small / (L) Front Floor Mat - Worked - Large</p>	<p>Remarks (R) Mirror - Scratch - Small / (R) Front Fender, Molding - Scratch - Small / (R) Step, In-panel, Side Spoiler - Scratch - Small / (R) Front Door, Molding - Scratch - Medium / (R) Rear Door, Molding - Scratch - Medium / (R) Rear Fender, Molding - Scratch & Dent - Medium / Rear Bumper, Lamps, Panels - Scratch & Dent - Large / Trunk Hood, Rear Gate - Scratch & Dent - Medium / (L) Rear Door, Molding - Scratch & Dent - Medium / (L) Mirror - Scratch - Small / (L) Front Fender, Molding - Scratch - Small / Front Bumper, Grille, Lamps - Scratch & Dent - Small / Bonnet, Headlight - Dent - Medium / (L) Rear Fender, Molding - Scratch & Dent - Medium / (L) Front Door, Molding - Scratch - Small / Roof - Dent - Small</p>
