## General Information

<b>Make</b>	Toyota	<b>Model</b>	Vios
<b>YOM</b>	2023	<b>Odo Meter Reading</b>	14,415
<b>Registration No.</b>	CCA4318	<b>Chassis No.</b>	PA1B18F30P4220798
<b>CC</b>	1.3	<b>Transmission</b>	M/T
<b>Fuel Type</b>	Gas	<b>Type of Body</b>	Sedan
<b>Colour</b>	Blackish Red Mica

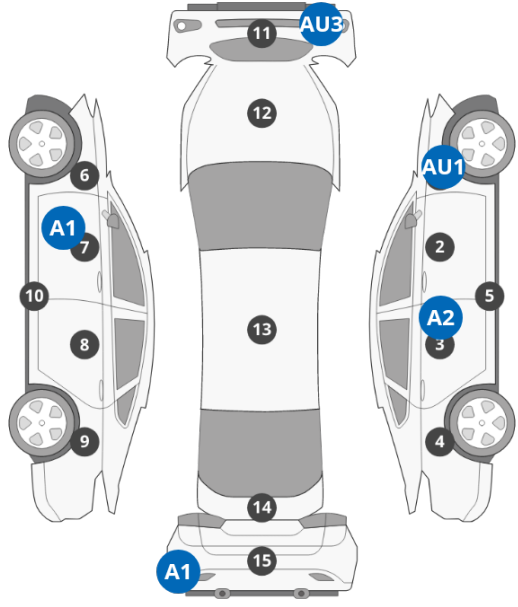
<p><b>A</b> : Scratch <b>AU</b> : Scratch &amp; Dent <b>B</b> : Modified <b>C</b> : Corrosion <b>G</b> : Stone chip <b>P</b> : Faded <b>S</b> : Rust <b>SC</b> : Rust &amp; Corrosion <b>U</b> : Dent <b>X</b> : Defective <b>Y</b> : Crack, Gap</p>
<b>Remarks</b> Ceiling - Grime - Minimal / (L) Front Floor Mat - Worked - Small	<b>Remarks</b> (R) Front Fender, Molding - Scratch & Dent - Minimal / (R) Rear Door, Molding - Scratch - Small / Rear Bumper, Lamps, Panels - Scratch - Minimal / (L) Front Door, Molding - Scratch - Minimal / Front Bumper, Grille, Lamps - Scratch & Dent - Medium
<b>Frame Evaluation :</b> <span style="float: right;"><b>A</b></span>	<b>Functional Evaluation :</b> <span style="float: right;"><b>A</b></span>

<b>Inspector Notes</b>
With LTO plate, 3keys,with jack and Tools, No spare tire, traces of splash paint ,scratch headlight taillights
