## General Information

<b>Make</b>	Toyota	<b>Model</b>	Vios
<b>YOM</b>	2023	<b>Odo Meter Reading</b>	58,234
<b>Registration No.</b>	NHJ5954	<b>Chassis No.</b>	PA1B18F36P4219526
<b>CC</b>	1.3	<b>Transmission</b>	CVT
<b>Fuel Type</b>	Gas	<b>Type of Body</b>	Sedan
<b>Colour</b>	Blue

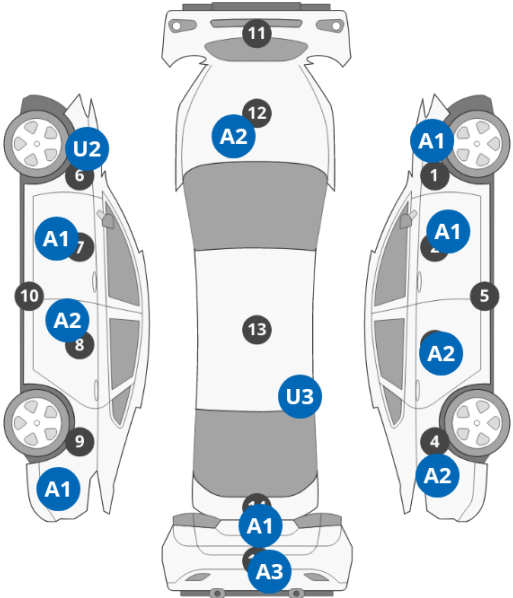
<p><b>A</b> : Scratch <b>AU</b> : Scratch &amp; Dent <b>B</b> : Modified <b>C</b> : Corrosion <b>G</b> : Stone chip <b>P</b> : Faded <b>S</b> : Rust <b>SC</b> : Rust &amp; Corrosion <b>U</b> : Dent <b>X</b> : Defective <b>Y</b> : Crack, Gap</p>
<b>Remarks</b> Rear Seat - Grime - Large / (R) Front Seat - Grime - Medium / (R) Front Trim - Grime - Small / Trunk Room - Worn, Scratch, Cut, Crack - Small / (L) Front Trim - Grime - Large / (L) Front Seat - Grime - Medium / (L) Front Floor Mat - Grime - Small / Dashboard - Worn, Scratch, Cut, Crack - Small / Ceiling - Grime - Small / Console, Switchs, Vents - Worn, Scratch, Cut, Crack - Small	<b>Remarks</b> (L) Front Fender, Molding - Dent - Small / (L) Rear Door, Molding - Scratch - Small / Bonnet, Headlight - Scratch - Small / (R) Front Door, Molding - Scratch - Minimal / (R) Rear Door, Molding - Scratch - Small / (R) Rear Fender, Molding - Scratch - Small / Roof - Dent - Medium / Trunk Hood, Rear Gate - Scratch - Minimal / Rear Bumper, Lamps, Panels - Scratch - Medium / (L) Rear Fender, Molding - Scratch - Minimal / (L) Front Door, Molding - Scratch - Minimal / (R) Front Fender, Molding - Scratch - Minimal
