## General Information

<b>Make</b>	Toyota	<b>Model</b>	Vios
<b>YOM</b>	2024	<b>Odo Meter Reading</b>	21,655
<b>Registration No.</b>	NHQ1576	<b>Chassis No.</b>	PA1B18F32R4240330
<b>CC</b>	1.3	<b>Transmission</b>	CVT
<b>Fuel Type</b>	Gas	<b>Type of Body</b>	Sedan
<b>Colour</b>	Black

## Body / Panel Condition

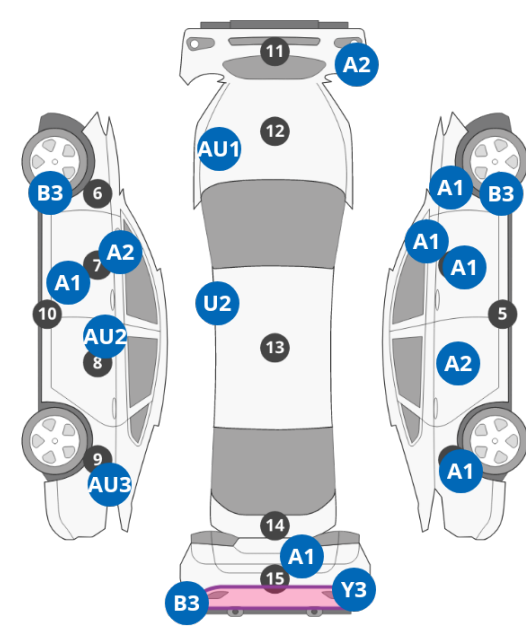
<p><b>A</b> : Scratch <b>AU</b> : Scratch &amp; Dent <b>B</b> : Modified <b>C</b> : Corrosion <b>G</b> : Stone chip <b>P</b> : Faded <b>S</b> : Rust <b>SC</b> : Rust &amp; Corrosion <b>U</b> : Dent <b>X</b> : Defective <b>Y</b> : Crack, Gap</p>
<p><b>Remarks</b> (L) Front Floor Mat - Worked - Small / (L) Front Seat - Worn - Yes / (L) Front Trim - Grime - Minimal / (R) Front Trim - Grime - Minimal / (R) Front Seat - Grime - Minimal</p>	<p><b>Remarks</b> (R) Front Fender, Molding - Modified - Medium / (R) Front Fender, Molding - Scratch - Minimal / (R) Mirror - Scratch - Minimal / (R) Front Door, Molding - Scratch - Minimal / (R) Rear Door, Molding - Scratch - Small / (R) Rear Fender, Molding - Scratch - Minimal / Rear Bumper, Lamps, Panels - Repair mark - Yes / Rear Bumper, Lamps, Panels - Crack, Gap - Medium / Trunk Hood, Rear Gate - Scratch - Minimal / Rear Bumper, Lamps, Panels - Modified - Medium / (L) Rear Fender, Molding - Scratch &amp; Dent - Medium / (L) Rear Door, Molding - Scratch &amp; Dent - Small / (L) Front Fender, Molding - Modified - Medium / (L) Mirror - Scratch - Small / (L) Front Door, Molding - Scratch - Minimal / Front Bumper, Grille, Lamps - Scratch - Small / Bonnet, Headlight - Scratch &amp; Dent - Minimal / Roof - Dent - Small</p>
