## General Information

<b>Make</b>	Toyota	<b>Model</b>	Vios
<b>YOM</b>	2024	<b>Odo Meter Reading</b>	25,980
<b>Registration No.</b>	NFR7465	<b>Chassis No.</b>	PA1B18F31R4251934
<b>CC</b>	1.3	<b>Transmission</b>	CVT
<b>Fuel Type</b>	Gas	<b>Type of Body</b>	Sedan
<b>Colour</b>	Blue

## Body / Panel Condition

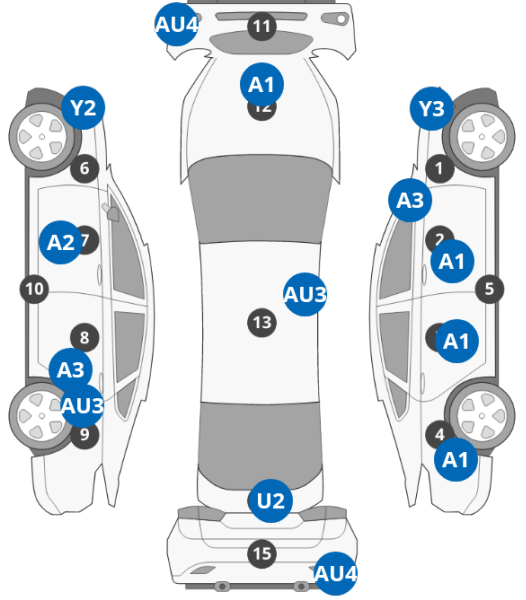
<p><b>A</b> : Scratch <b>AU</b> : Scratch &amp; Dent <b>B</b> : Modified <b>C</b> : Corrosion <b>G</b> : Stone chip <b>P</b> : Faded <b>S</b> : Rust <b>SC</b> : Rust &amp; Corrosion <b>U</b> : Dent <b>X</b> : Defective <b>Y</b> : Crack, Gap</p>
<p><b>Remarks</b> Rear Seat - Grime - Large / (R) Front Seat - Grime - Large / (L) Front Seat - Grime - Large / (L) Front Floor Mat - Worked - Large</p>	<p><b>Remarks</b> (R) Front Door - Repair Traces - Yes / (R) Step - Repair Traces - Yes / (R) Front Fender - Repair Traces - Yes / (L) Front Fender - Repair Traces - Yes / (L) Front Door - Repair Traces - Yes / (L) Step - Repair Traces - Yes / (L) Rear Door - Repair Traces - Yes / (R) Rear Door - Repair Traces - Yes / (L) Rear Fender, Molding - Scratch &amp; Dent - Medium / (L) Rear Door, Molding - Scratch - Medium / Rear Bumper, Lamps, Panels - Scratch &amp; Dent - Large / Trunk Hood, Rear Gate - Dent - Small / (R) Mirror - Scratch - Medium / Front Bumper, Grille, Lamps - Scratch &amp; Dent - Large / (L) Front Fender, Molding - Crack, Gap - Small / (R) Front Fender, Molding - Crack, Gap - Medium / Roof - Scratch &amp; Dent - Medium / (R) Front Door, Molding - Scratch - Minimal / (R) Rear Door, Molding - Scratch - Minimal / (R) Rear Fender, Molding - Scratch - Minimal / (L) Front Door, Molding - Scratch - Small / Bonnet, Headlight - Scratch - Minimal</p>
