## General Information

<b>Make</b>	Toyota	<b>Model</b>	Vios
<b>YOM</b>	2024	<b>Odo Meter Reading</b>	17,422
<b>Registration No.</b>	DBF8182	<b>Chassis No.</b>	PA1B18F30R4253352
<b>CC</b>	1.3	<b>Transmission</b>	CVT
<b>Fuel Type</b>	Gas	<b>Type of Body</b>	Sedan
<b>Colour</b>	Black

## Body / Panel Condition

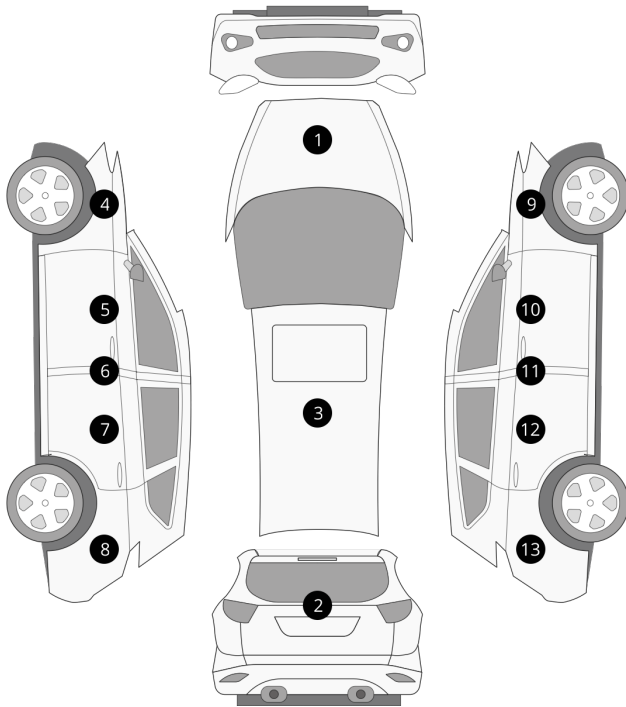
#	Area	Thickness(um)			
		Average	Value1	Value2	Value3/4
1	Bonnet	113.0	122	102	115
2	Boot Lid	105.3	102	106	108
3	Roof	102.2	101	107	96/105
4	Left Front Fender	95.8	94	99	95
5	Left Front Door	102.0	102	102	102
6	Center Panel Left				
7	Left Rear Door	105.0	106	104	105
8	Left Back Panel	111.6	126	101	108
9	Right Front Fender	102.9	110	99	100
10	Right Front Door	103.5	98	101	112
11	Center Panel Right				
12	Right Rear Door	105.6	98	106	113
13	Right Back Panel	103.3	100	106	104

<b>Interior Evaluation :</b> <span style="color: red; font-size: 1.5em;">A</span>	<b>Exterior Evaluation :</b> <span style="color: red; font-size: 1.5em;">D</span>
<p><b>a</b> : Cut, Fray <b>d</b> : Loose, Deformed <b>k</b> : Animal Hair <b>s</b> : Smell <b>t</b> : Cigarette Burns <b>x</b> : Defective <b>y</b> : Stain</p>	<p><b>A</b> : Scratch <b>AU</b> : Scratch &amp; Dent <b>B</b> : Modified <b>C</b> : Corrosion <b>G</b> : Stone chip <b>P</b> : Faded <b>S</b> : Rust <b>SC</b> : Rust &amp; Corrosion <b>U</b> : Dent <b>X</b> : Defective <b>Y</b> : Crack, Gap</p>
<p><b>Remarks</b> (R) Front Trim - Grime - Minimal / Trunk Room - Worn, Scratch, Cut, Crack - Minimal / (L) Front Trim - Grime - Small / (L) Front Seat - Grime - Small / Ceiling - Grime - Minimal / Dashboard - Traces of Adhesive Tape - Yes</p>	<p><b>Remarks</b> (L) Front Fender, Molding - Scratch - Small / (L) Front Door, Molding - Scratch - Medium / (L) Rear Door, Molding - Scratch - Small / (L) Mirror - Scratch - Minimal / Front Bumper, Grille, Lamps - Scratch - Medium / Bonnet, Headlight - Scratch - Small / (R) Front Fender, Molding - Scratch &amp; Dent - Medium / (R) Front Door, Molding - Scratch &amp; Dent - Large / (R) Rear Door, Molding - Scratch &amp; Dent - Small / (R) Rear Fender, Molding - Scratch - Medium / Rear Bumper, Lamps, Panels - Scratch - Small / Trunk Hood, Rear Gate - Scratch - Minimal / (L) Rear Fender, Molding - Scratch - Minimal / Roof - Scratch - Small</p>
