## General Information

| Make | Toyota | Model | Veloz |
| Registration No. | FAR7589 | Chassis No. | MHFAB1BY2R3086449 |

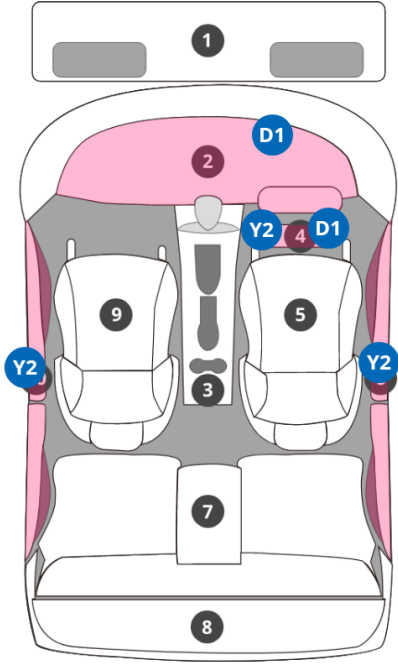
| Interior Evaluation : <b>A</b> | Exterior Evaluation : <b>E</b> |
| <b>Remarks</b><br>Dashboard - Worked - Minimal / Carpet - Worked - Minimal / (R) Front Trim - Grime - Small / (L) Front Trim - Grime - Small / (L) Front Floor Mat - Grime - Small | <b>Remarks</b><br>Rear End Panel - Repair Traces - Yes / Bonnet, Headlight - Scratch - Small / (R) Front Fender, Molding - Scratch - Small / (R) Mirror - Scratch - Small / (R) Rear Door, Molding - Scratch - Small / (R) Rear Fender, Molding - Scratch - Small / Trunk Hood, Rear Gate - Scratch & Dent - Large / Rear Bumper, Lamps, Panels - Scratch & Dent - Large / Rear Windshield - Damaged - Large / (L) Rear Door, Molding - Scratch - Small / Front Bumper, Grille, Lamps - Scratch & Dent - Large / (L) Front Fender, Molding - Scratch - Small / (L) Front Door, Molding - Scratch - Small |

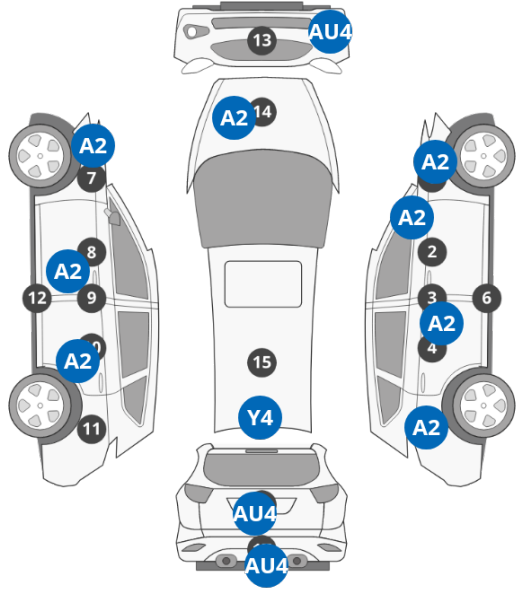
| Inspector Notes |
|---|
| Damaged rear windshield, rear bumper and trunk door. Gap at left and right rear fender. With warranty booklet and seat cover. Without spare tire, jack and tools. 2 keys. Remote key issue. With LTO plate. |
