## General Information

<b>Make</b>	Suzuki	<b>Model</b>	Carry
<b>YOM</b>	2025	<b>Odo Meter Reading</b>	5,953
<b>Registration No.</b>	NKN8260	<b>Chassis No.</b>	MHYDC61T9SJ270616
<b>CC</b>	1.5	<b>Transmission</b>	M/T
<b>Fuel Type</b>	Gas	<b>Type of Body</b>	Utility Vehicle
<b>Colour</b>	White

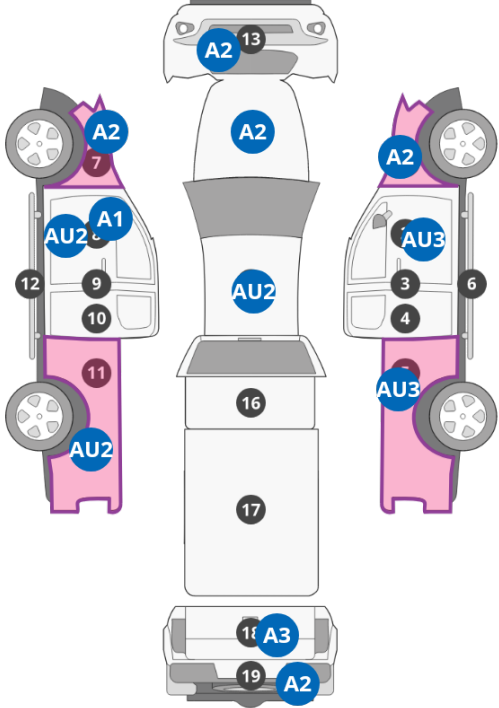
<p><b>A</b> : Scratch <b>AU</b> : Scratch &amp; Dent <b>B</b> : Modified <b>C</b> : Corrosion <b>G</b> : Stone chip <b>P</b> : Faded <b>S</b> : Rust <b>SC</b> : Rust &amp; Corrosion <b>U</b> : Dent <b>X</b> : Defective <b>Y</b> : Crack, Gap</p>
<b>Remarks</b> Ceiling - Grime - Small / (L) Front Floor Mat - Missing - Yes / (R) Front Floor Mat - Missing - Yes / Mat Other - Missing - Yes	<b>Remarks</b> (L) Side Gate - Repair mark - Yes / (L) Side Gate - Scratch & Dent - Small / (L) Front Door, Molding - Scratch & Dent - Small / (L) Front Fender, Molding - Scratch - Small / (L) Mirror - Scratch - Minimal / Front Bumper, Grille, Lamps - Scratch - Small / Front Panel - Scratch - Small / (R) Front Fender, Molding - Scratch - Small / (R) Front Door, Molding - Scratch & Dent - Medium / (R) Side Gate - Scratch & Dent - Medium / Rear Bumper, Lamps, Panels - Scratch - Small / Roof - Scratch & Dent - Small / Rear Gate - Scratch - Medium / (R) Rear Wheel, Cover - Cap Missing - Yes / (L) Rear Wheel, Cover - Cap Missing - Yes / (L) Front Wheel, Cover - Cap Missing - Yes / (R) Front Wheel, Cover - Cap Missing - Yes
