## General Information

Date & Time: 30, Oct, 2025 15:43

<b>Make</b>	Suzuki	<b>Model</b>	Dzire
<b>YOM</b>	2025	<b>Odo Meter Reading</b>	5,625
<b>Registration No.</b>	NKO9128	<b>Chassis No.</b>	MBHZF63S0SG592140
<b>CC</b>	1.2	<b>Transmission</b>	A/T
<b>Fuel Type</b>	Gas	<b>Type of Body</b>	Sedan
<b>Colour</b>	Red

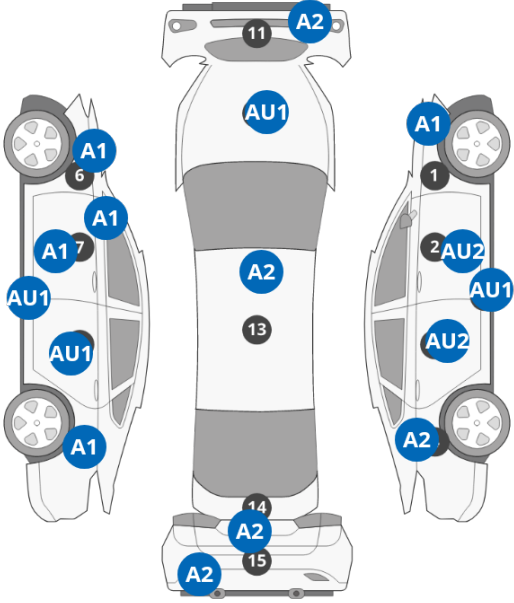
<p><b>A</b> : Scratch <b>AU</b> : Scratch &amp; Dent <b>B</b> : Modified <b>C</b> : Corrosion <b>G</b> : Stone chip <b>P</b> : Faded <b>S</b> : Rust <b>SC</b> : Rust &amp; Corrosion <b>U</b> : Dent <b>X</b> : Defective <b>Y</b> : Crack, Gap</p>
<b>Remarks</b> Defects not found	<b>Remarks</b> (L) Front Fender, Molding - Scratch - Minimal / (L) Front Door, Molding - Scratch - Minimal / (L) Mirror - Scratch - Minimal / (L) Rear Door, Molding - Scratch & Dent - Minimal / (L) Rear Fender, Molding - Scratch - Minimal / (L) Step, In-panel, Side Spoiler - Scratch & Dent - Minimal / Trunk Hood, Rear Gate - Scratch - Small / Rear Bumper, Lamps, Panels - Scratch - Small / Bonnet, Headlight - Scratch & Dent - Minimal / Front Bumper, Grille, Lamps - Scratch - Small / (R) Front Fender, Molding - Scratch - Minimal / (R) Front Door, Molding - Scratch & Dent - Small / (R) Rear Door, Molding - Scratch & Dent - Small / (R) Rear Fender, Molding - Scratch - Small / (R) Step, In-panel, Side Spoiler - Scratch & Dent - Minimal
