General Information

Make	Toyota	Model	Innova
YOM	2024	Odo Meter Reading	47,180
Registration No.	CCC3614	Chassis No.	PAZJA8EMXP0132026
CC	2.8	Transmission	A/T
Fuel Type	Diesel	Type of Body	Wagon
Colour	Red Mica Metallic

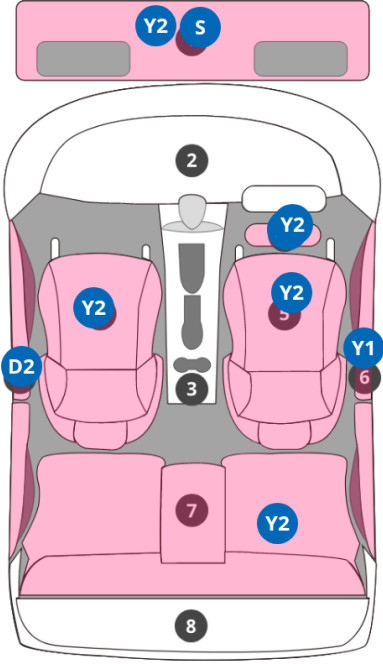
Interior Evaluation : A	Exterior Evaluation : D

<p>a : Cut, Fray d : Loose, Deformed k : Animal Hair s : Smell t : Cigarette Burns x : Defective y : Stain</p>

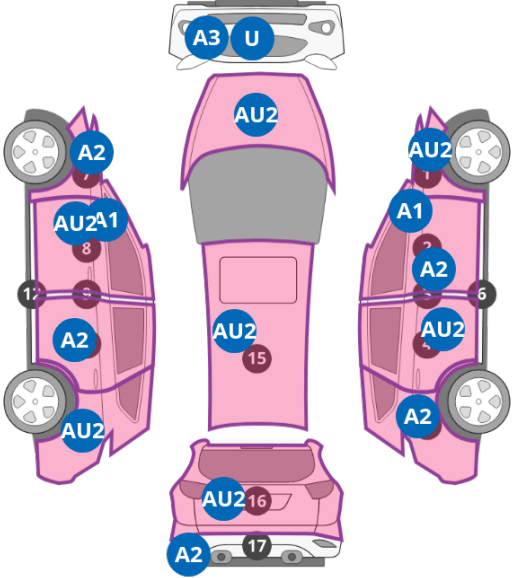
<p>A : Scratch AU : Scratch & Dent B : Modified C : Corrosion G : Stone chip P : Faded S : Rust SC : Rust & Corrosion U : Dent X : Defective Y : Crack, Gap</p>
<p>Remarks (L) Front Seat - Grime - Small / Rear Seat - Grime - Small / (L) Front Trim - Worked - Small / (R) Front Trim - Grime - Minimal</p>	<p>Remarks (R) Front Door - Repair Traces - Yes / (R) Front Fender - Repair Traces - Yes / Bonnet - Repair Traces - Yes / (L) Front Fender - Repair Traces - Yes / (L) Front Door - Repair Traces - Yes / (L) Rear Door - Repair Traces - Yes / (L) Rear Fender - Repair Traces - Yes / Trunk Hood, Rear Gate - Repair Traces - Yes / (R) Rear Fender - Repair Traces - Yes / (R) Rear Door - Repair Traces - Yes / Roof - Repair Traces - Yes / (R) Front Fender, Molding - Repair mark - Yes / (R) Front Door, Molding - Repair mark - Yes / (R) Rear Door, Molding - Repair mark - Yes / (R) Rear Fender, Molding - Repair mark - Yes / Trunk Hood, Rear Gate - Repair mark - Yes / (L) Rear Fender, Molding - Repair mark - Yes / (L) Rear Door, Molding - Repair mark - Yes / (L) Front Door, Molding - Repair mark - Yes / (L) Front Fender, Molding - Repair mark - Yes / Bonnet, Headlight - Repair mark - Yes / Member (Bolted) - Dent - Yes / Front Bumper, Grille, Lamps - Scratch - Medium / (L) Front Fender, Molding - Scratch - Small / (R) Rear Fender, Molding - Scratch - Small / (R) Rear Door, Molding - Scratch & Dent - Small / (R) Front Door, Molding - Scratch - Small / (R) Front Fender, Molding - Scratch & Dent - Small / Bonnet, Headlight - Scratch & Dent - Small</p>
