General Information

Make	Toyota	Model	Vios
YOM	2024	Odo Meter Reading	71,863
Registration No.	CAZ8486	Chassis No.	PA1B18F32P4238204
CC	1.3	Transmission	CVT
Fuel Type	Gas	Type of Body	Sedan
Colour	Black

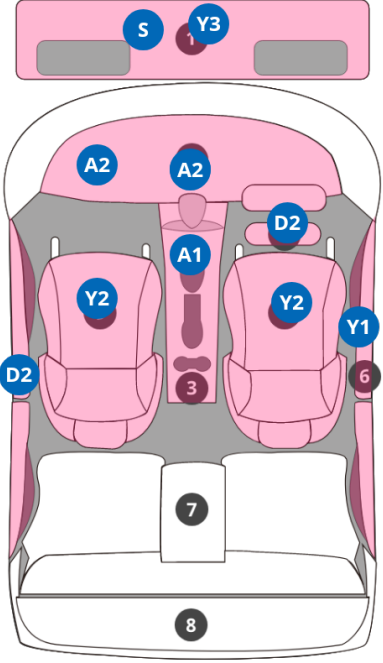
Interior Evaluation : C	Exterior Evaluation : D

<p>a : Cut, Fray d : Loose, Deformed k : Animal Hair s : Smell t : Cigarette Burns x : Defective y : Stain</p>

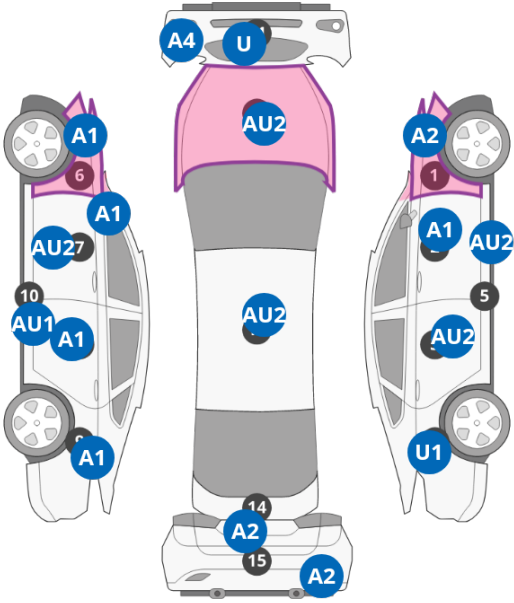
<p>A : Scratch AU : Scratch & Dent B : Modified C : Corrosion G : Stone chip P : Faded S : Rust SC : Rust & Corrosion U : Dent X : Defective Y : Crack, Gap</p>
<p>Remarks (L) Front Floor Mat - Worked - Small / (L) Front Trim - Worked - Small / (R) Front Trim - Grime - Minimal / Ceiling - Grime - Medium / Overall Interior - Smell - Yes / (L) Front Seat - Grime - Small / (R) Front Seat - Grime - Small / Steering Wheel - Worn, Peel, Crack - Small / Dashboard - Traces of Adhesive Tape - Yes / Dashboard - Worn, Scratch, Cut, Crack - Small / Console, Switches, Vents - Worn, Scratch, Cut, Crack - Minimal</p>	<p>Remarks (R) Front Fender - Repair Traces - Yes / Bonnet - Repair Traces - Yes / (L) Front Fender - Repair Traces - Yes / (L) Front Fender, Molding - Repair mark - Yes / (R) Front Fender, Molding - Repair mark - Yes / Bonnet, Headlight - Repair mark - Yes / Member (Bolted) - Dent - Yes / Bonnet, Headlight - Scratch & Dent - Small / Front Bumper, Grille, Lamps - Scratch - Large / (L) Front Fender, Molding - Scratch - Minimal / (L) Mirror - Scratch - Minimal / (L) Front Door, Molding - Scratch & Dent - Small / (L) Rear Door, Molding - Scratch - Minimal / (L) Step, In-panel, Side Spoiler - Scratch & Dent - Minimal / (L) Rear Fender, Molding - Scratch - Minimal / Trunk Hood, Rear Gate - Scratch - Small / Roof - Scratch & Dent - Small / (R) Front Door, Molding - Scratch - Minimal / (R) Front Fender, Molding - Scratch - Small / (R) Rear Door, Molding - Scratch & Dent - Small / (R) Step, In-panel, Side Spoiler - Scratch & Dent - Small / (R) Rear Fender, Molding - Dent - Minimal / Rear Bumper, Lamps, Panels - Scratch - Small</p>
