## General Information

<b>Make</b>	Toyota	<b>Model</b>	Vios
<b>YOM</b>	2024	<b>Odo Meter Reading</b>	8,425
<b>Registration No.</b>	NFR3397	<b>Chassis No.</b>	PA1B18F38R4251669
<b>CC</b>	1.3	<b>Transmission</b>	CVT
<b>Fuel Type</b>	Gas	<b>Type of Body</b>	Sedan
<b>Colour</b>	Red

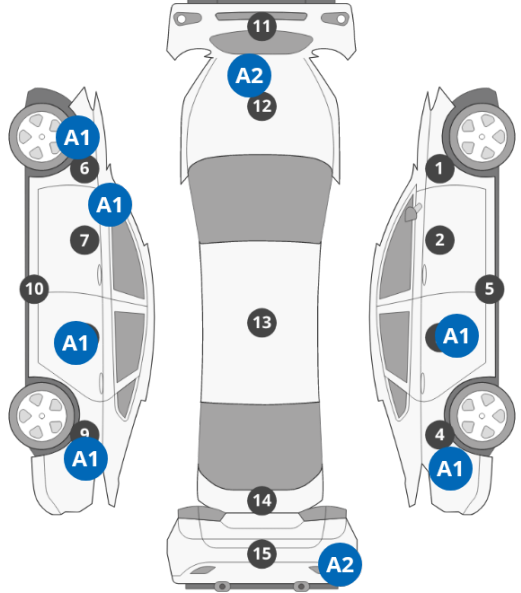
<p><b>A</b> : Scratch <b>AU</b> : Scratch &amp; Dent <b>B</b> : Modified <b>C</b> : Corrosion <b>G</b> : Stone chip <b>P</b> : Faded <b>S</b> : Rust <b>SC</b> : Rust &amp; Corrosion <b>U</b> : Dent <b>X</b> : Defective <b>Y</b> : Crack, Gap</p>
<p><b>Remarks</b> Rear Seat - Grime - Medium / (R) Front Seat - Grime - Medium / (R) Front Trim - Grime - Small / (L) Front Trim - Grime - Medium / Console, Switches, Vents - Worn, Scratch, Cut, Crack - Small / Dashboard - Worn, Scratch, Cut, Crack - Minimal</p>	<p><b>Remarks</b> Rear Bumper, Lamps, Panels - Scratch - Small / (L) Rear Fender, Molding - Scratch - Minimal / (L) Rear Door, Molding - Scratch - Minimal / (L) Mirror - Scratch - Minimal / (L) Front Fender, Molding - Scratch - Minimal / Bonnet, Headlight - Scratch - Small / (R) Rear Door, Molding - Scratch - Minimal / (R) Rear Fender, Molding - Scratch - Minimal</p>
