General Information

Date & Time: 04, Nov, 2025 13:08

Make	Toyota	Model	Vios
YOM	2023	Odo Meter Reading	98,114
Registration No.	NHC8378	Chassis No.	PA1B18F33P4201274
CC	1.3	Transmission	CVT
Fuel Type	Gas	Type of Body	Sedan
Colour	Blue

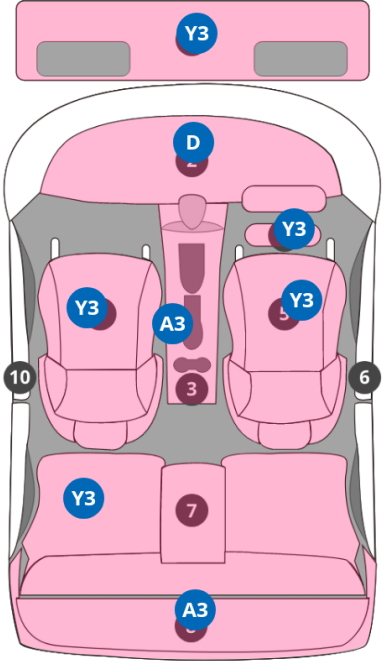
Interior Evaluation : C	Exterior Evaluation : E

<p>A : Scratch AU : Scratch & Dent B : Modified C : Corrosion G : Stone chip P : Faded S : Rust SC : Rust & Corrosion U : Dent X : Defective Y : Crack, Gap</p>
<p>Remarks Rear Seat - Grime - Medium / Trunk Room - Worn, Scratch, Cut, Crack - Medium / (R) Front Seat - Grime - Medium / (L) Front Seat - Grime - Medium / (L) Front Floor Mat - Grime - Medium / Dashboard - Traces of Adhesive Tape - Yes / Ceiling - Grime - Medium / Console, Switchs, Vents - Worn, Scratch, Cut, Crack - Medium</p>	<p>Remarks (R) Front Door - Repair Traces - Yes / (R) Front Fender - Repair Traces - Yes / Bonnet - Repair Traces - Yes / (L) Front Fender - Repair Traces - Yes / (L) Front Door - Repair Traces - Yes / (L) Rear Door - Repair Traces - Yes / (L) Rear Fender - Repair Traces - Yes / Trunk Hood, Rear Gate - Repair Traces - Yes / (R) Rear Fender - Repair Traces - Yes / (R) Rear Door - Repair Traces - Yes / Roof - Repair Traces - Yes / Member (Bolted) - Dent - Yes / (L) Front Fender, Molding - Repair mark - Yes / Bonnet, Headlight - Repair mark - Yes / (R) Front Fender, Molding - Repair mark - Yes / (R) Front Fender, Molding - Scratch & Dent - Large / (R) Front Door, Molding - Scratch & Dent - Large / (L) Front Fender, Molding - Scratch & Dent - Large / Front Bumper, Grille, Lamps - Scratch & Dent - Large / (L) Step, In-panel, Side Spoiler - Crack, Gap - Medium / (L) Mirror - Scratch - Minimal / (L) Rear Door, Molding - Scratch - Medium / (L) Rear Fender, Molding - Scratch - Medium / Trunk Hood, Rear Gate - Dent - Medium / Rear Bumper, Lamps, Panels - Scratch - Small / (R) Rear Fender, Molding - Scratch - Large / (R) Rear Door, Molding - Scratch & Dent - Medium / Bonnet, Headlight - Scratch & Dent - Small / Roof - Scratch - Medium / (R) Step, In-panel, Side Spoiler - Scratch & Dent - Large</p>
