## General Information

Date & Time: 04, Nov, 2025 08:46

<b>Make</b>	Toyota	<b>Model</b>	Hilux
<b>YOM</b>	2024	<b>Odo Meter Reading</b>	15,456
<b>Registration No.</b>	NHM8860	<b>Chassis No.</b>	MR0JB8DD4P3549866
<b>CC</b>	2.4	<b>Transmission</b>	A/T
<b>Fuel Type</b>	Diesel	<b>Type of Body</b>	Pickup
<b>Colour</b>	Gray

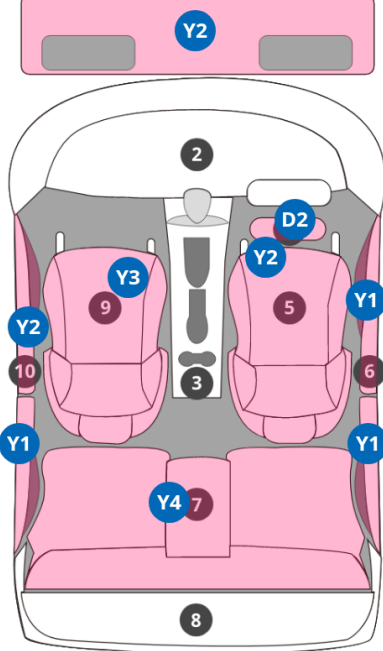
<b>Interior Evaluation :</b> <span style="float: right; color: red; font-weight: bold;">C</span>	<b>Exterior Evaluation :</b> <span style="float: right; color: red; font-weight: bold;">D</span>

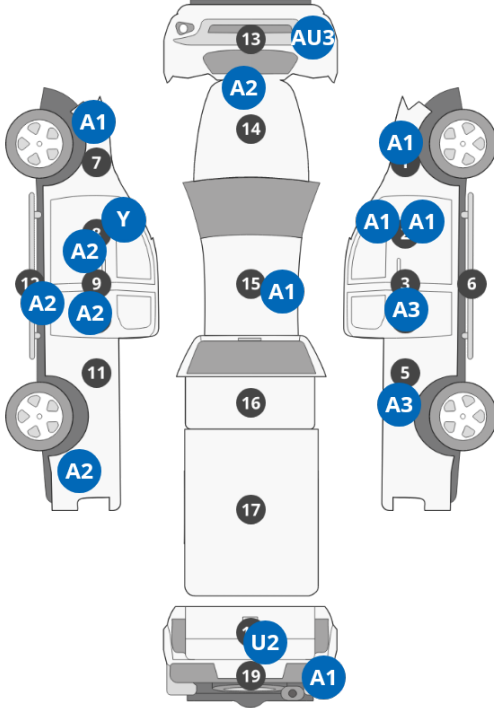
<p><b>A</b> : Scratch <b>AU</b> : Scratch &amp; Dent <b>B</b> : Modified <b>C</b> : Corrosion <b>G</b> : Stone chip <b>P</b> : Faded <b>S</b> : Rust <b>SC</b> : Rust &amp; Corrosion <b>U</b> : Dent <b>X</b> : Defective <b>Y</b> : Crack, Gap</p>
<p><b>Remarks</b> Ceiling - Grime - Small / (L) Front Floor Mat - Worked - Small / (L) Front Seat - Grime - Medium / (R) Front Seat - Grime - Small / Rear Seat - Grime - Large / (L) Front Trim - Grime - Small / (R) Rear Trim - Grime - Minimal / (R) Front Trim - Grime - Minimal / (L) Rear Trim - Grime - Minimal</p>	<p><b>Remarks</b> (R) Front Fender, Molding - Scratch - Minimal / (R) Mirror - Scratch - Minimal / (R) Rear Door, Molding - Scratch - Medium / (R) Front Door, Molding - Scratch - Minimal / (R) Side Gate - Scratch - Medium / Rear Bumper, Lamps, Panels - Scratch - Minimal / Rear Gate - Dent - Small / (L) Side Gate - Scratch - Small / (L) Rear Door, Molding - Scratch - Small / (L) Step, In-panel, Side Spoiler - Scratch - Small / (L) Front Door, Molding - Scratch - Small / (L) Mirror - Scratch - Minimal / (L) Front Fender, Molding - Scratch - Minimal / Front Bumper, Grille, Lamps - Scratch &amp; Dent - Medium / Bonnet, Headlight - Scratch - Small / Roof - Scratch - Minimal / (L) Mirror - Crack - Damaged</p>

<p><b>Inspector Notes</b></p>
<p>with warranty booklet, with jack and tools, with spare tire, with LTO plate, scratches on headlight and tail light</p>
