## General Information

Date & Time: 03, Nov, 2025 15:43

<b>Make</b>	Toyota	<b>Model</b>	Fortuner
<b>YOM</b>	2025	<b>Odo Meter Reading</b>	26,039
<b>Registration No.</b>	VAC2712	<b>Chassis No.</b>	MHFCB3GS5R0497158
<b>CC</b>	2.4	<b>Transmission</b>	A/T
<b>Fuel Type</b>	Diesel	<b>Type of Body</b>	Wagon
<b>Colour</b>	Silver

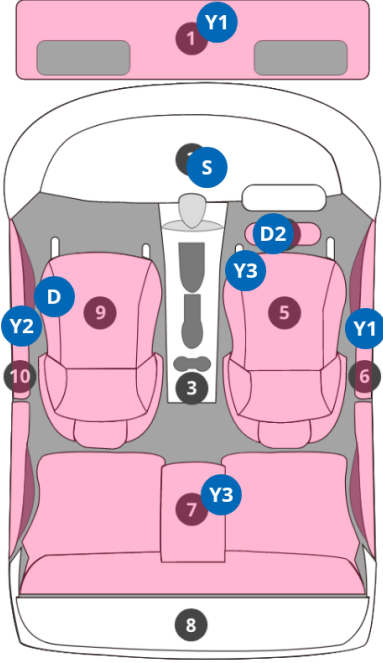
<b>Interior Evaluation :</b> <span style="float: right; color: red; font-weight: bold;">B</span>	<b>Exterior Evaluation :</b> <span style="float: right; color: red; font-weight: bold;">C</span>

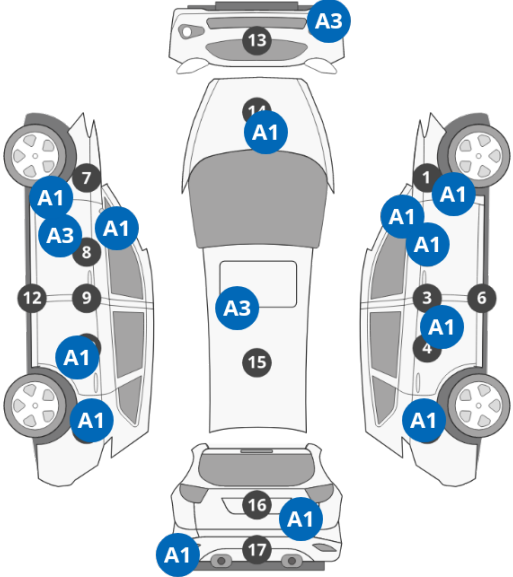
<p><b>A</b> : Scratch <b>AU</b> : Scratch &amp; Dent <b>B</b> : Modified <b>C</b> : Corrosion <b>G</b> : Stone chip <b>P</b> : Faded <b>S</b> : Rust <b>SC</b> : Rust &amp; Corrosion <b>U</b> : Dent <b>X</b> : Defective <b>Y</b> : Crack, Gap</p>
<p><b>Remarks</b> (R) Front Seat - Grime - Medium / (L) Front Seat - Worn - Yes / (L) Front Floor Mat - Worked - Small / Rear Seat - Grime - Medium / (R) Front Trim - Grime - Minimal / (L) Front Trim - Grime - Small / Ceiling - Grime - Minimal / Overall Interior - Smell - Yes</p>	<p><b>Remarks</b> (R) Front Fender, Molding - Scratch - Minimal / (R) Mirror - Scratch - Minimal / (R) Front Door, Molding - Scratch - Minimal / (R) Rear Door, Molding - Scratch - Minimal / (R) Rear Fender, Molding - Scratch - Minimal / Rear Bumper, Lamps, Panels - Scratch - Minimal / Trunk Hood, Rear Gate - Scratch - Minimal / (L) Rear Fender, Molding - Scratch - Minimal / (L) Front Door, Molding - Scratch - Medium / (L) Rear Door, Molding - Scratch - Minimal / (L) Mirror - Scratch - Minimal / (L) Front Fender, Molding - Scratch - Minimal / Front Bumper, Grille, Lamps - Scratch - Medium / Bonnet, Headlight - Scratch - Minimal / Roof - Scratch - Medium</p>
