## General Information

<b>Make</b>	Toyota	<b>Model</b>	Vios
<b>YOM</b>	2023	<b>Odo Meter Reading</b>	129,525
<b>Registration No.</b>	NHI6819	<b>Chassis No.</b>	PA1B18F30P4207761
<b>CC</b>	1.3	<b>Transmission</b>	CVT
<b>Fuel Type</b>	Gas	<b>Type of Body</b>	Sedan
<b>Colour</b>	Green

## Body / Panel Condition

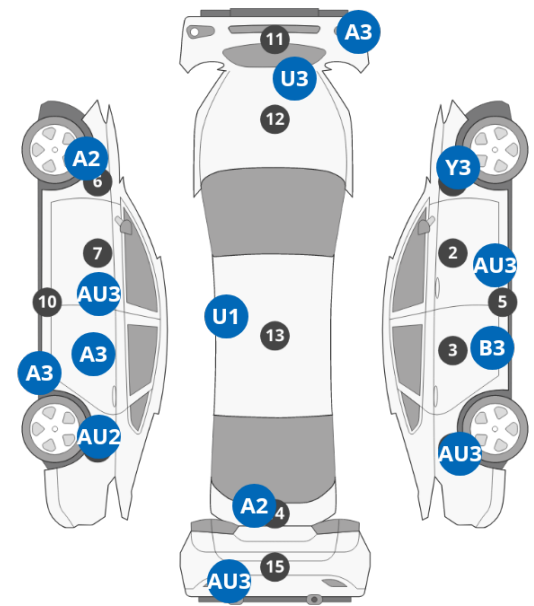
<p><b>A</b> : Scratch <b>AU</b> : Scratch &amp; Dent <b>B</b> : Modified <b>C</b> : Corrosion <b>G</b> : Stone chip <b>P</b> : Faded <b>S</b> : Rust <b>SC</b> : Rust &amp; Corrosion <b>U</b> : Dent <b>X</b> : Defective <b>Y</b> : Crack, Gap</p>
<p><b>Remarks</b>          Carpet - Worked - Minimal / (R) Front Seat - Grime - Medium / (L) Front Seat - Cut, Crack - Medium / (R) Front Trim - Grime - Minimal / (L) Front Trim - Grime - Small / Rear Seat - Grime - Medium / (R) Rear Trim - Grime - Small / (L) Rear Trim - Grime - Minimal / Trunk Room - Worked - Large / Console, Switchs, Vents - Worked - Minimal</p>	<p><b>Remarks</b>          (R) Front Fender - Repair Traces - Yes / Bonnet - Repair Traces - Yes / (L) Front Fender - Repair Traces - Yes / (L) Rear Fender - Repair Traces - Yes / (R) Front Fender, Molding - Crack, Gap - Medium / (R) Front Door, Molding - Scratch &amp; Dent - Medium / (R) Rear Door, Molding - Modified - Medium / (R) Rear Fender, Molding - Scratch &amp; Dent - Medium / Trunk Hood, Rear Gate - Scratch - Small / Rear Bumper, Lamps, Panels - Scratch &amp; Dent - Medium / (L) Rear Fender, Molding - Scratch &amp; Dent - Small / (L) Rear Door, Molding - Scratch - Medium / (L) Front Door, Molding - Scratch &amp; Dent - Medium / (L) Step, In-panel, Side Spoiler - Scratch - Medium / Overall Exterior - Faded(Color, Gloss) - Yes / (L) Front Fender, Molding - Scratch - Small / Front Bumper, Grille, Lamps - Scratch - Medium / Bonnet, Headlight - Dent - Medium / Roof - Dent - Minimal</p>
